**INTEGRITY OF TRANSPORTING PIPELINE GIRTH WELDS BASED  
ON FULL-SCALE TESTS UNDER COMPLEX LOADING  
CONDITIONS**

PHD THESES

**Ahmad Yasser Dakhel**

**Miskolc  
2025**

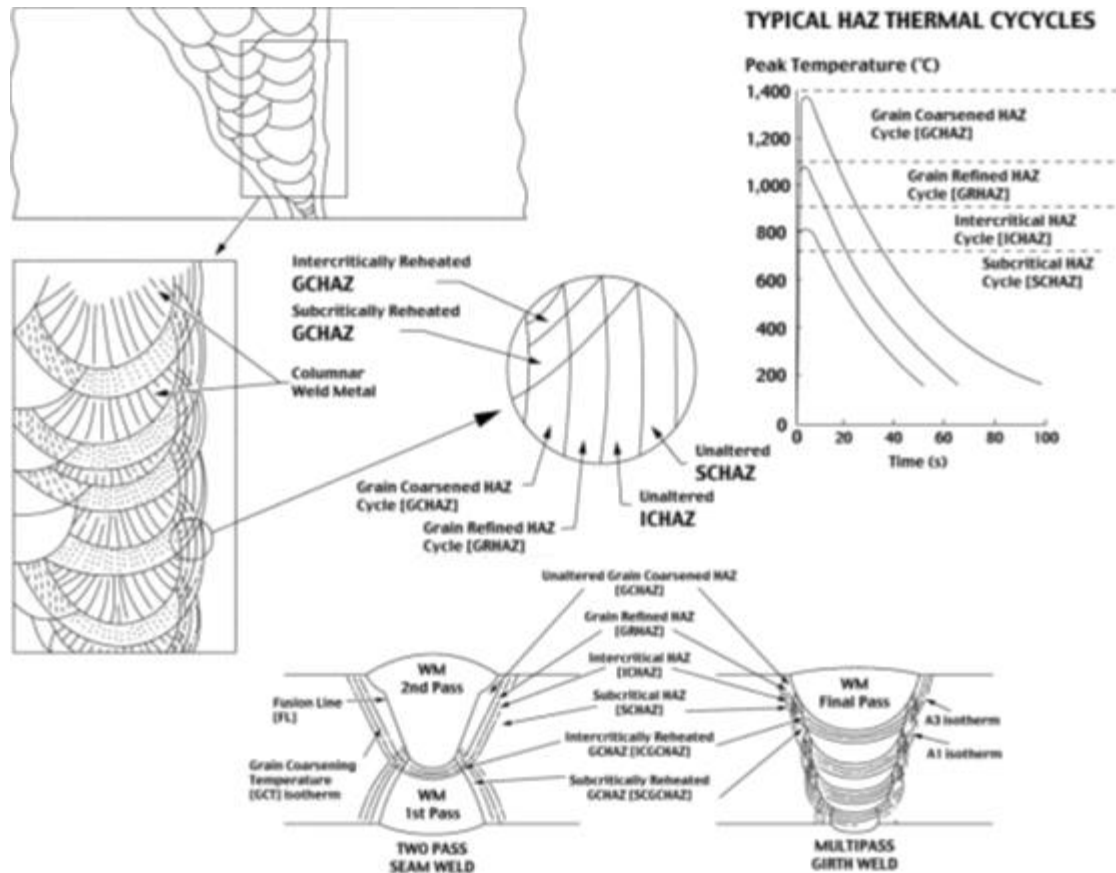
Figure 3 Microstructure of the heat-affected zone in two-pass and multiple pass welds based on [33]

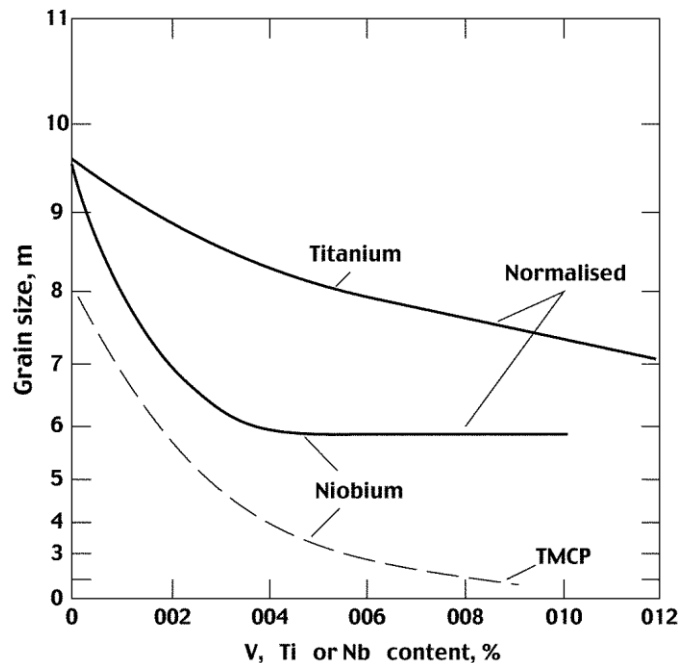
Figure 5 TMCP stands for Thermo-Mechanical Controlled Processing, and it shows the effect of niobium and titanium on ferrite particle size [34].

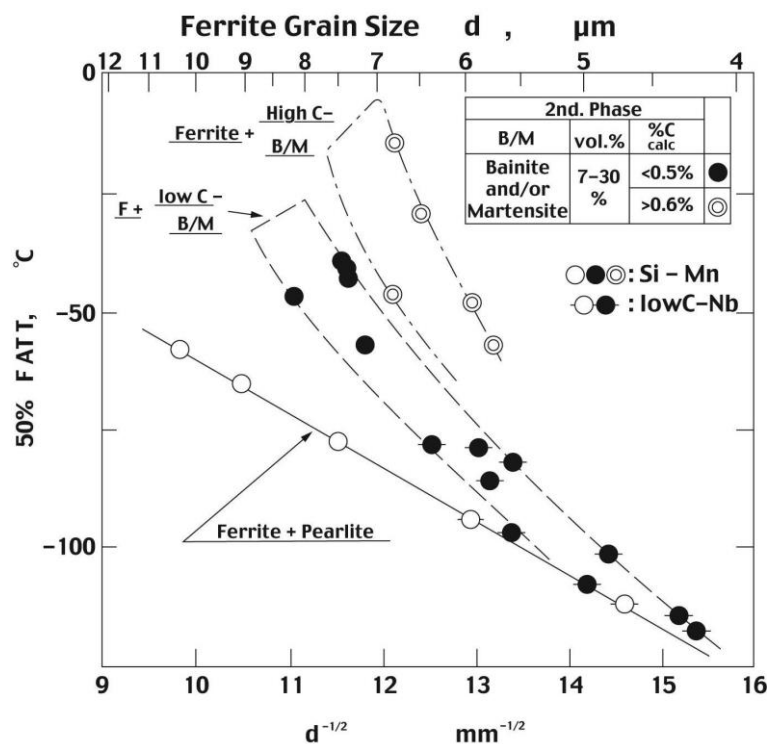
Figure 8 Effects of grain size and microstructure on toughness [37]

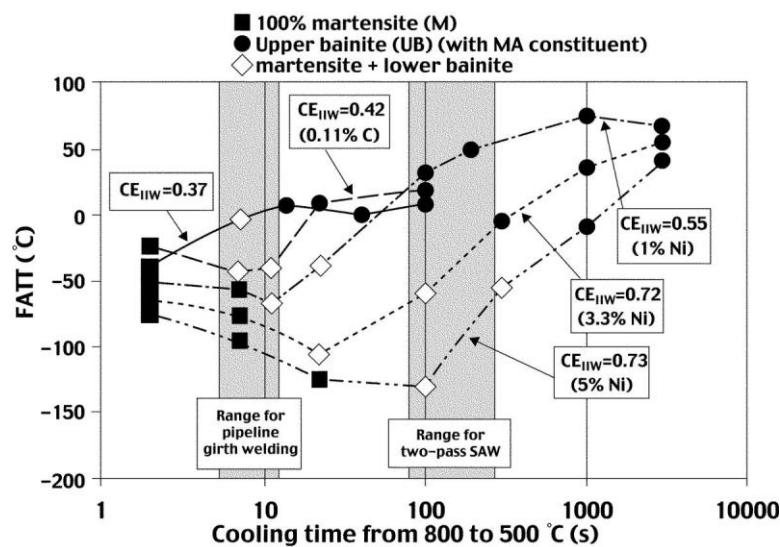
Figure 9 Correlation between FATT and cooling time for coarse-grained HAZ microstructures of pipeline steel [38].

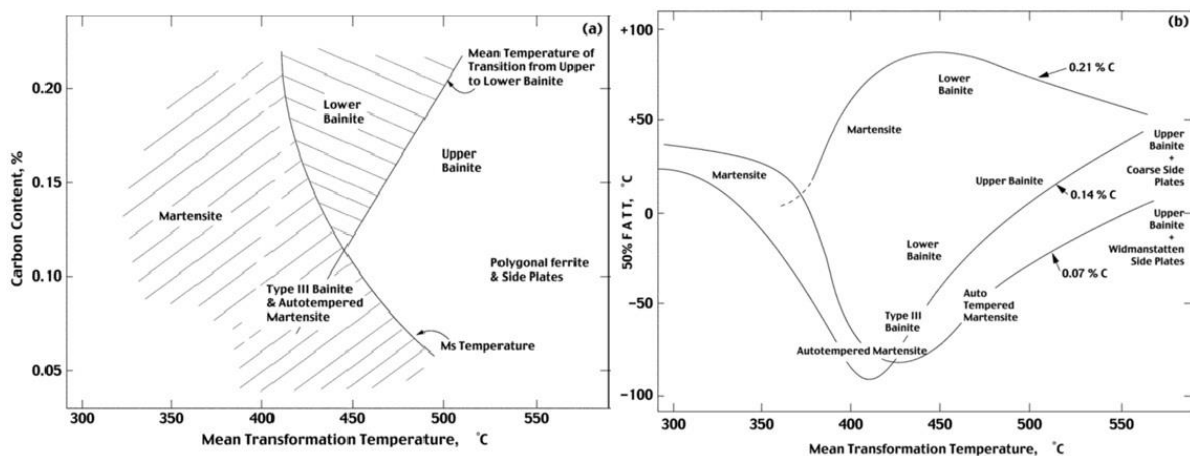
Figure 10 Influence of carbon content and microstructure on HAZ microstructure and toughness of structural steels [39].

The correlations shown in Figure 10 were calculated for basic C-Mn-Nb steels with no substantial alloy additions. The core concepts, however, have been proved to apply to a wide range of current steels with microalloying additions, as well as HSLA pipeline (Figure 9), structural, and shipbuilding steels. The degree to which the microalloying additions contribute to solid solution strengthening, grain size refinement, or carbonitride precipitation, there is a general 'shift' of the toughness values for these steels.

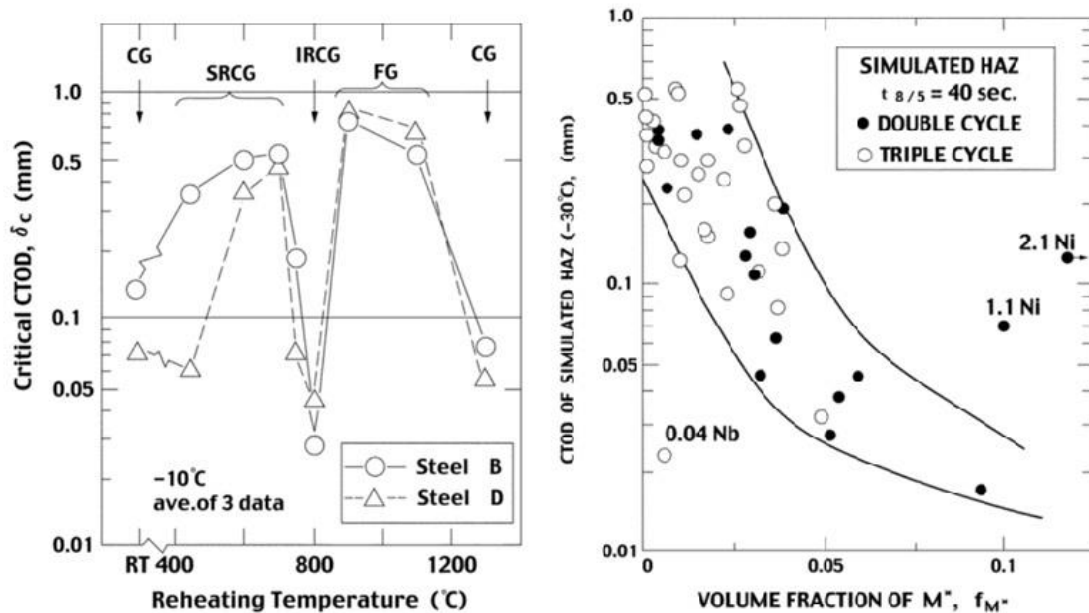
Figure 11 Toughness variations in simulated multipass weld HAZ microstructures(left), Dependence of intercritically reheated HAZ toughness on volume fraction of martensite islands (right) [40].

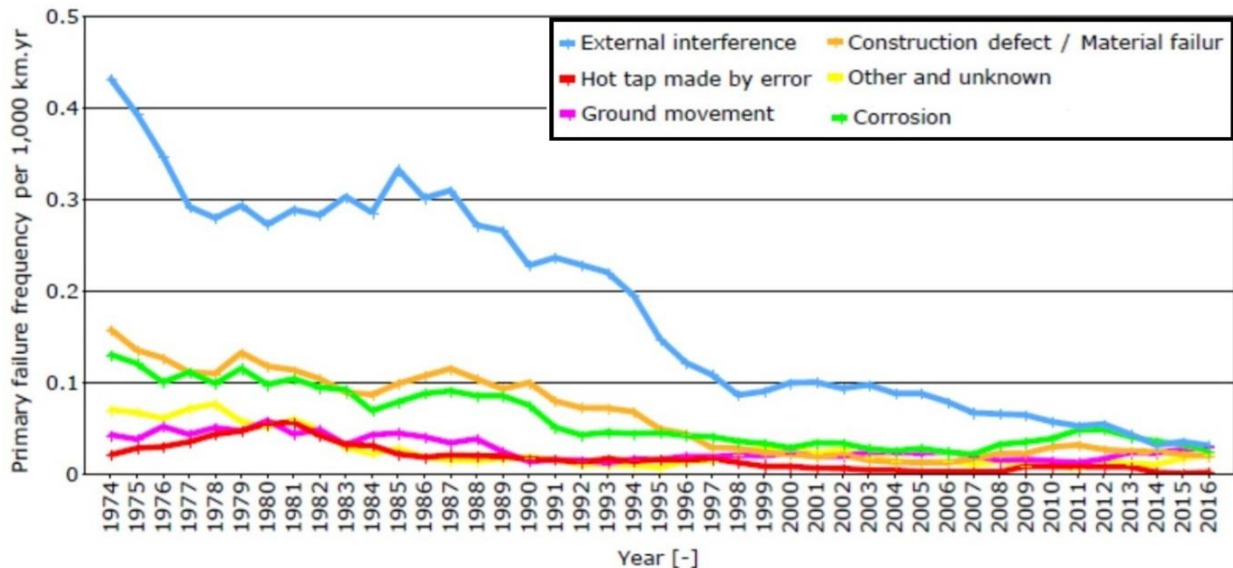
Figure 15 Failure frequencies of different causes by EGIG[47]

Figure 15 illustrates the decreasing failure frequencies per cause over the years, between 1974 and 2016. The decrease may be explained by technological developments, such as welding, inspection, condition monitoring using in-line inspection and improved procedures for damage prevention and detection. Improvements in the prevention of external interference incidents may be explained by more stringent enforcement of land use planning and the application of one-call systems for the digging activities of external parties. (Figure 15) In several countries, there is now a legal requirement to report digging activities. Companies have adopted appropriate actions, like supervision or marking of the pipeline in the direct neighborhood of the digging activities.[47]

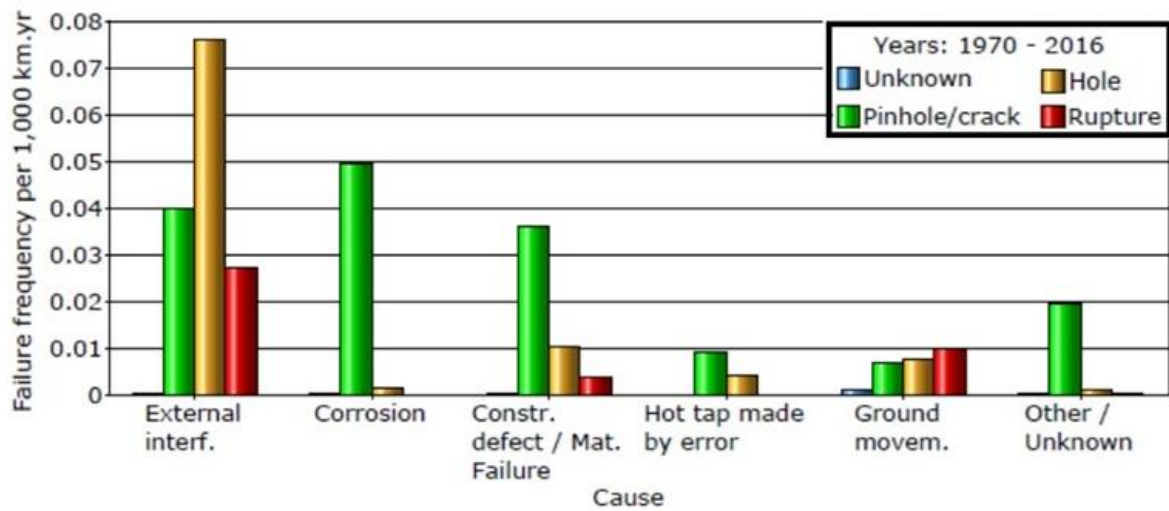
Figure 16 Relationship primary failure frequency, cause, and size of leak (1970-2016)[47]

Figure 16 and Figure 17 show the failure frequency per leak size and per-incident cause for 1970-2016 and 2007-2016, respectively.

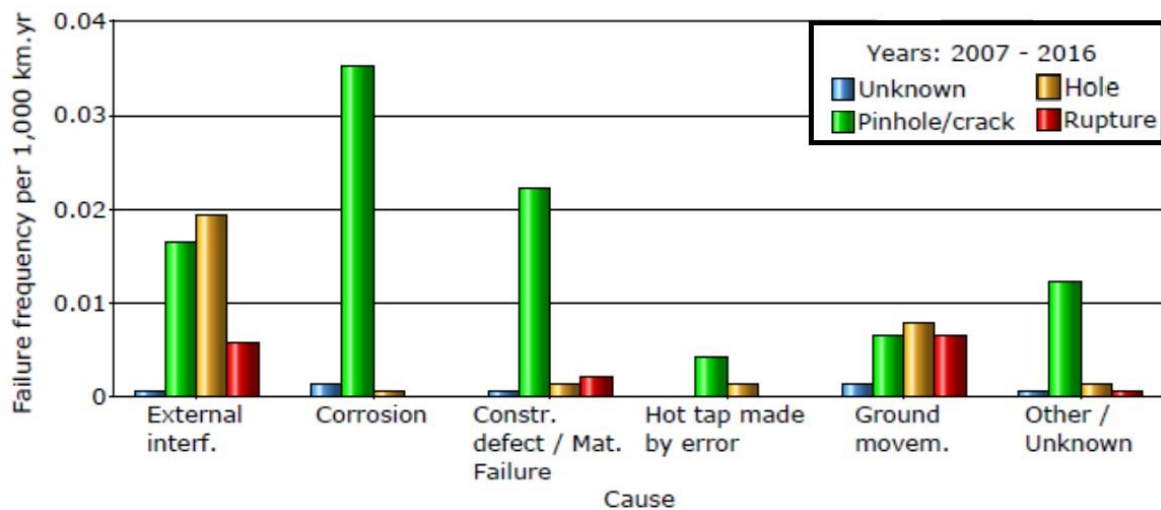
Figure 17 Relationship primary failure frequency, cause and size of leak [47]

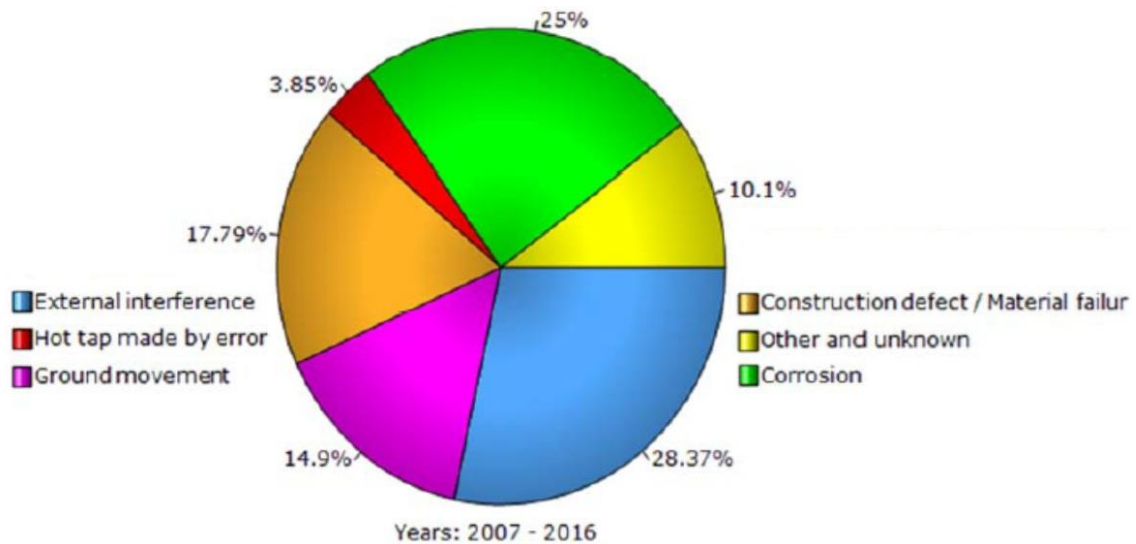
Figure 18 Failure causes by EGIG [47]

In Figure 18 the incident distribution per cause over the last 10 years is given. Corrosion and external interference incidents occurred at about the same rate. However, corrosion incidents tend to have smaller leak sizes.

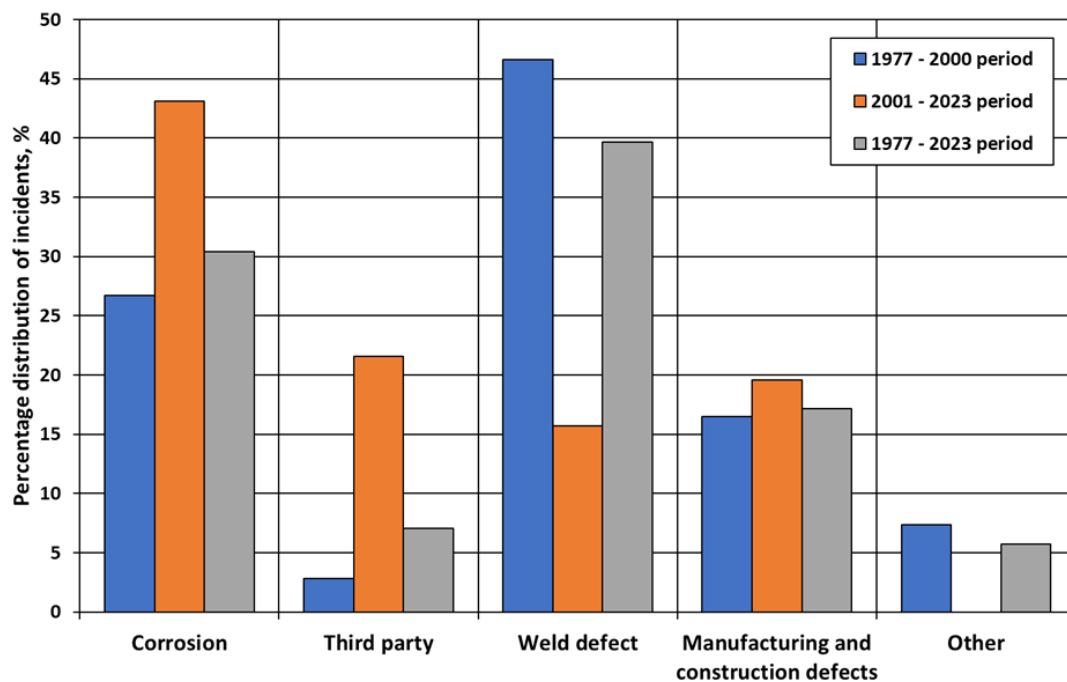
Figure 22 Distribution of root causes of failure events in the Hungarian high-pressure natural gas transmission pipeline system [50]

Figure 22 illustrates failure data from the Hungarian high-pressure natural gas transmission pipeline system [50], grouped similarly to Figure 21, with the overall time period divided into two sub-periods. Comparing the two periods, a slight rearrangement can be observed among corrosion, third-party damage, and weld defects as primary failure causes[3]. However, over the whole time period, weld defects represent the highest proportion. It is also important to note that weld defects typically occur in the early years (or decade) of operation, while the probability and share of corrosion-related failures increase with time. The high number and proportion of weld defects highlight the need for special attention to this category. According to Hungarian failure statistics significant part of failures were retraceable for weld defects, basically in girth welds. The comparison of the international data and the Hungarian statistics show, both in the past and present, that the ratio of the weld defects in Hungarian transporting pipelines is higher than the above-mentioned one and weld defects typically occur in girth welds.

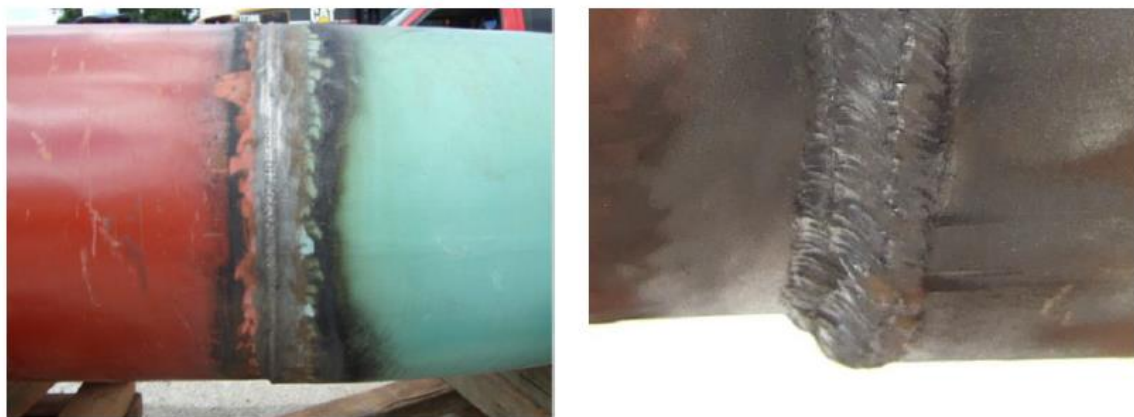
*Figure 25 Unacceptable treatment of an axial misalignment [54], [55]*

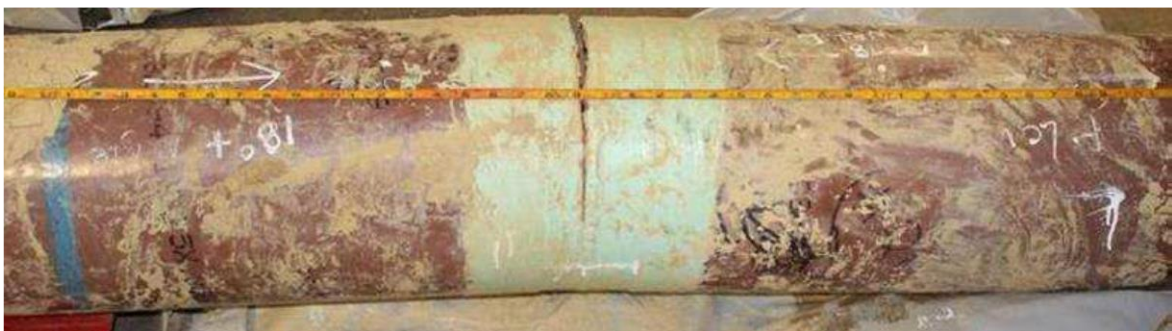
*Figure 27 Girth weld crack caused by different pipe and ditch profiles [56]*

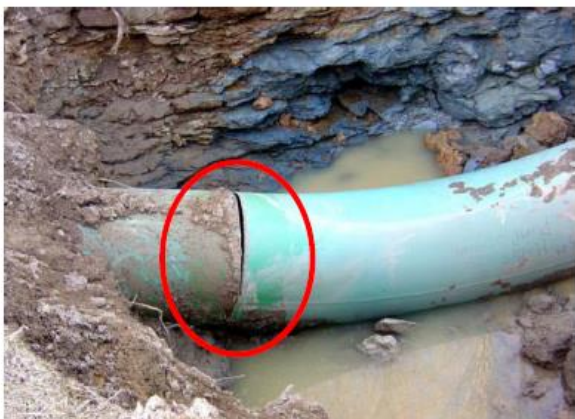
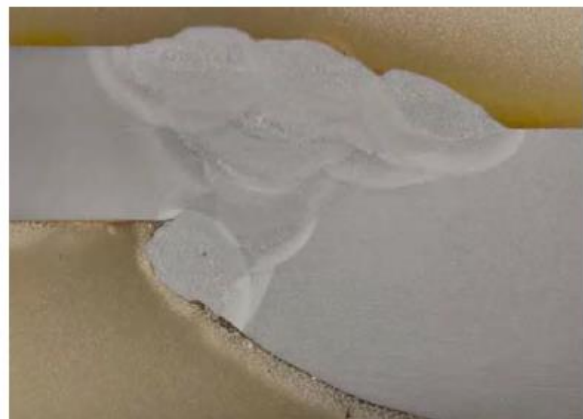
*Figure 28 Connection of different pipeline section with different shape and wall thickness [54]*

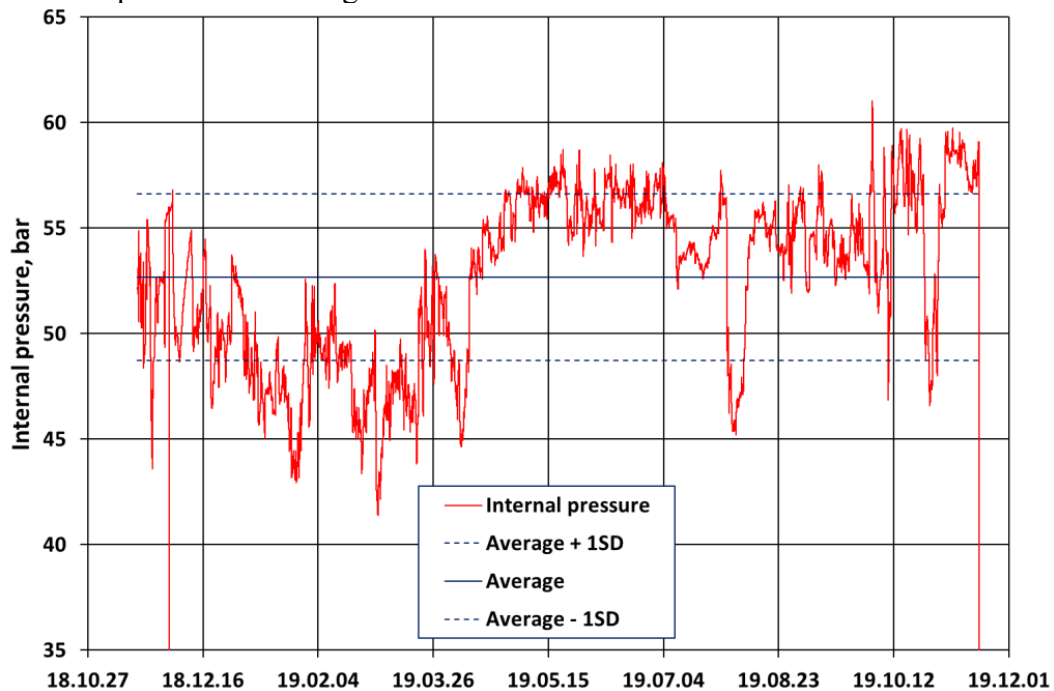
*Figure 29 Changing of the internal pressure on a Hungarian gas transporting pipeline section[57]*

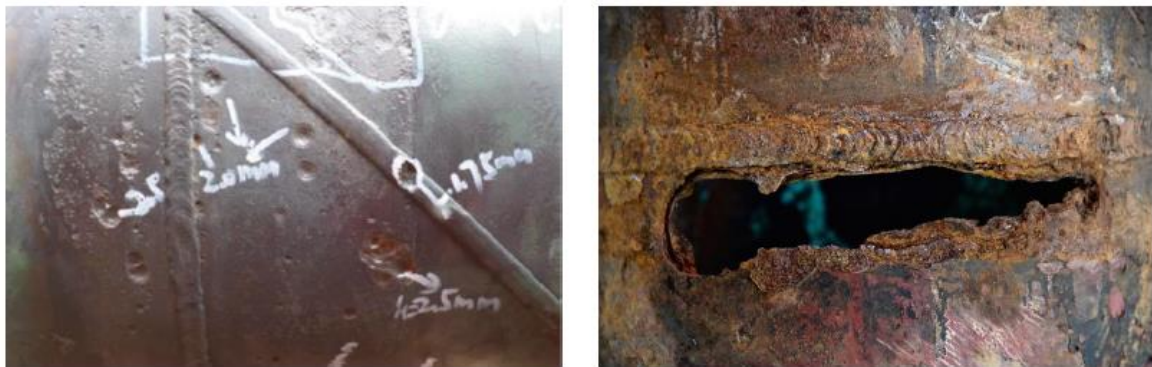
*Figure 30 Corrosion defects near and on pipeline welded joints [59], [60]*

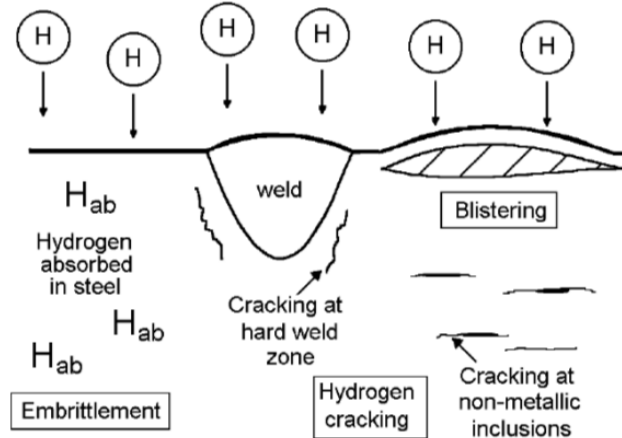
Figure 31 Hydrogen embrittlement, cracking and blistering processes [61]

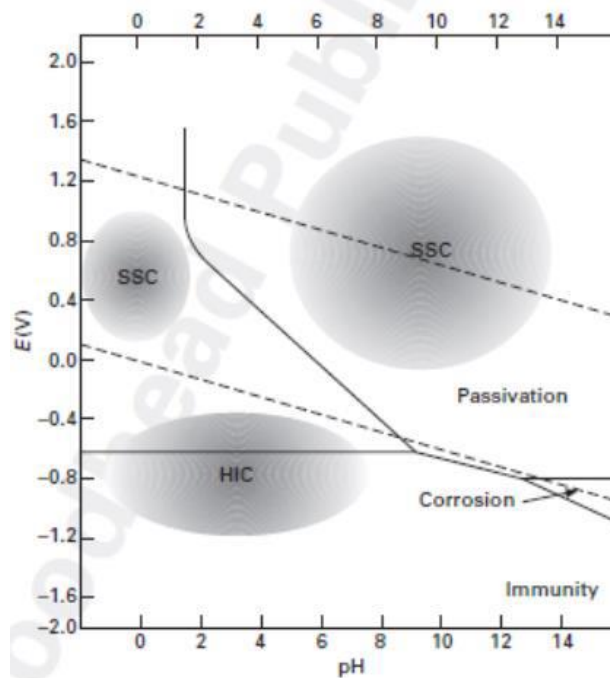
Figure 32 EAC modes as a function of pH and electrochemical potential for carbon steel [64]

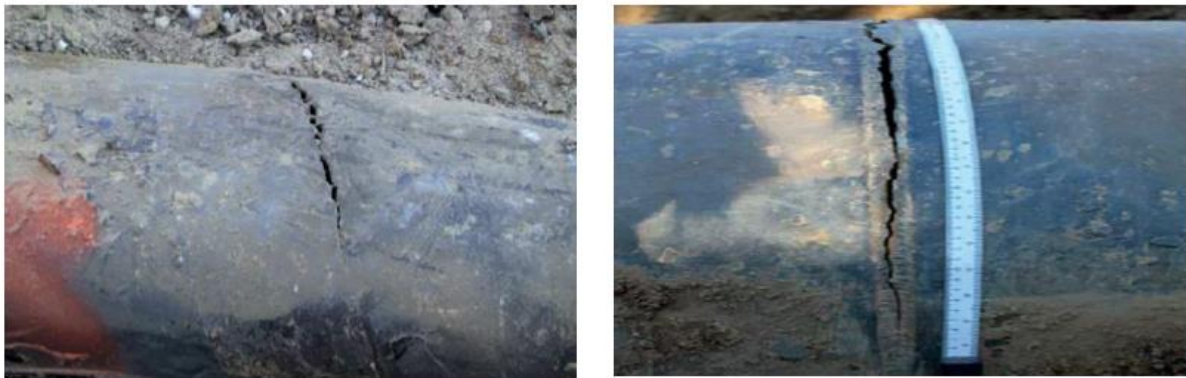
*Figure 33 Examples of stress corrosion cracking [65]*

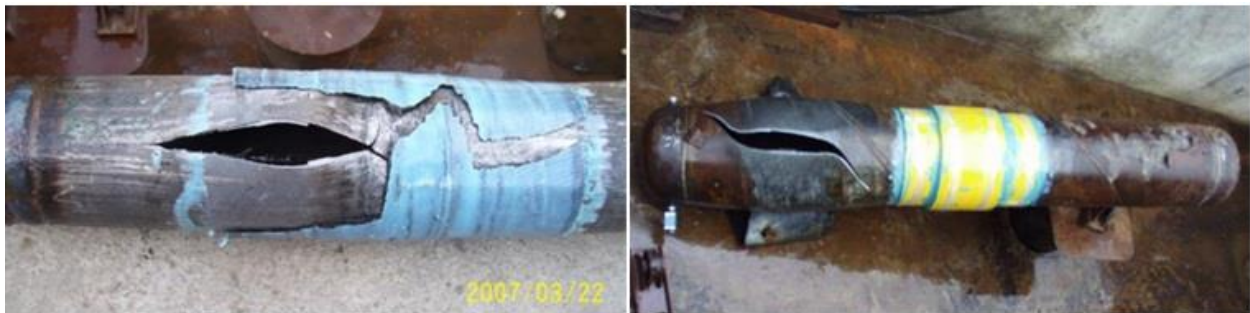
*Figure 34 Pipeline sections after fatigue and burst test with reinforced girth weld; left: system developed at University of Miskolc; right: Clock Spring repair system [66]*

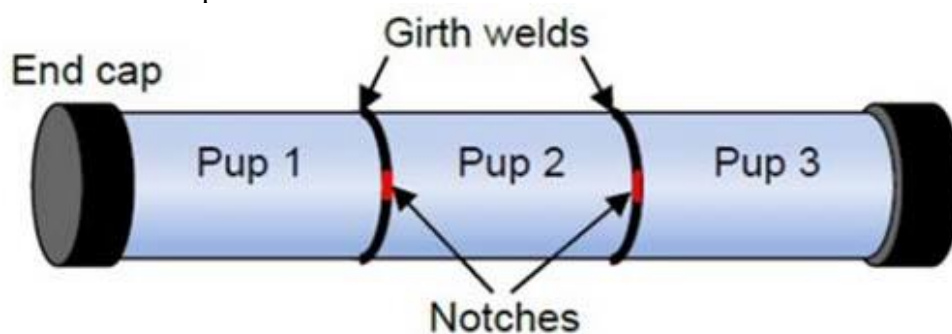
Figure 35 Full-Scale Test Specimen Schematic [69], [70]

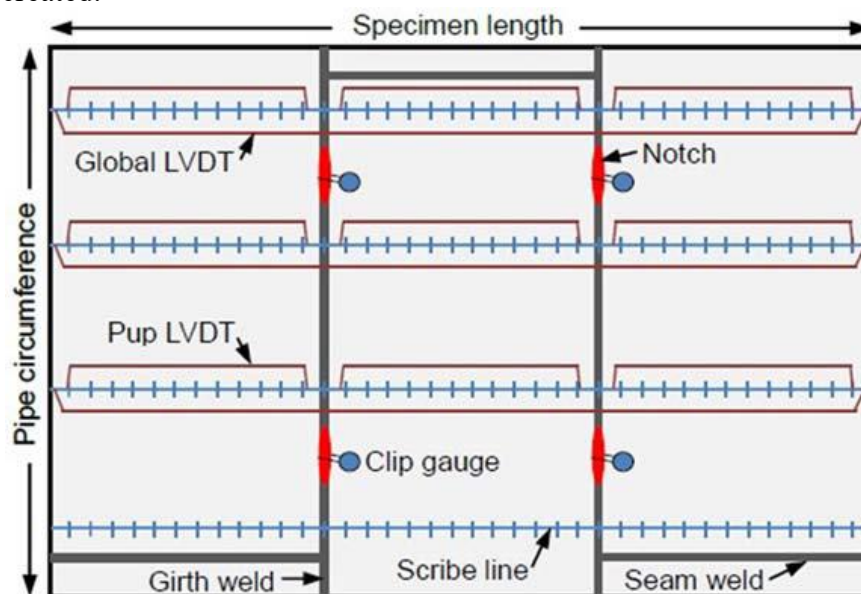
Figure 37 Instrumentation for Full-Scale Testing (unrolled pipe view) [69], [70]

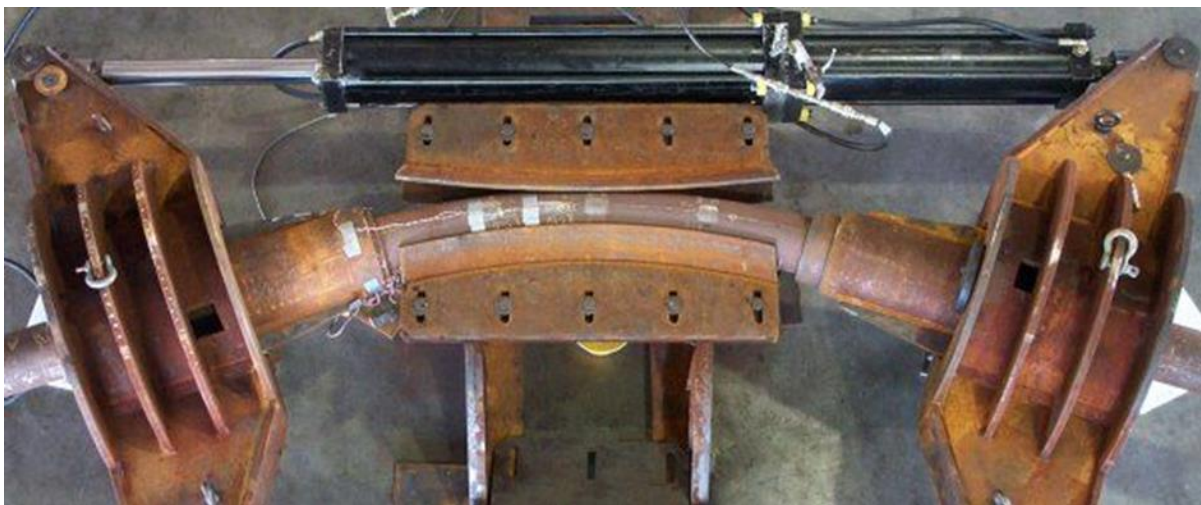
*Figure 38 Test setup for an experimental pipe section subjected to or capable of complex loading conditions [79]*

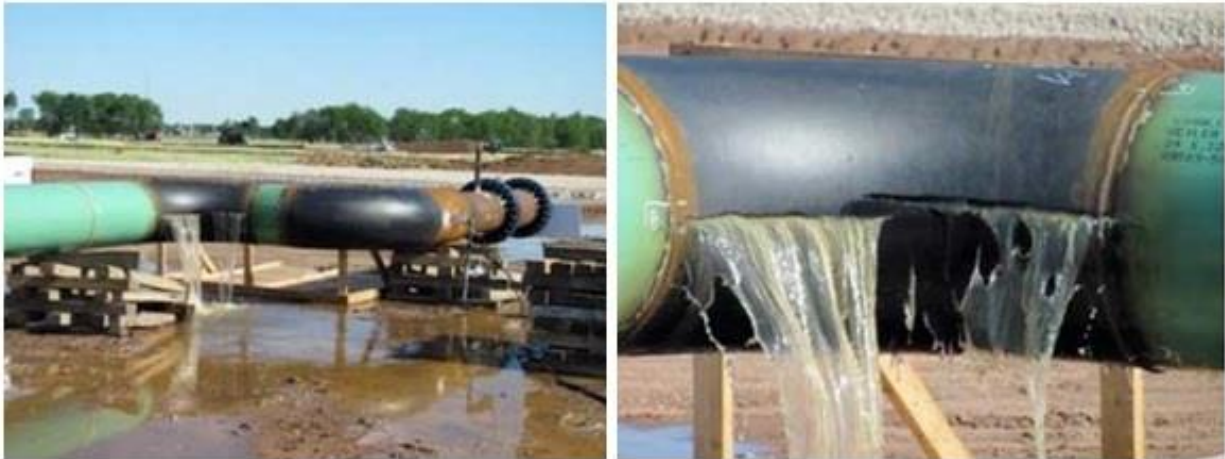
*Figure 42 Catastrophic failure of a pipe arch section during a pressure test [102]*

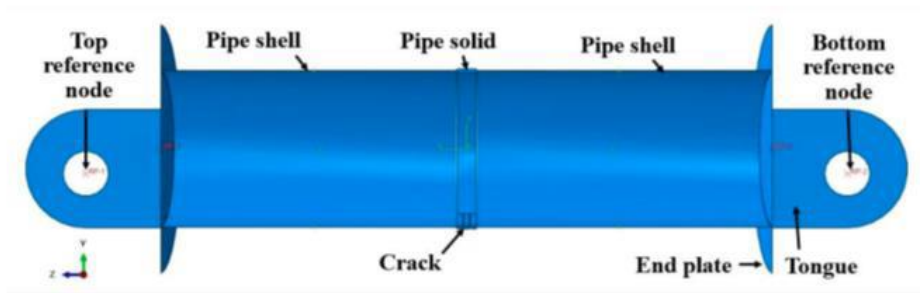
Figure 45 Pipeline XFEM model components assembled, displaying geometry and reference points.[75]

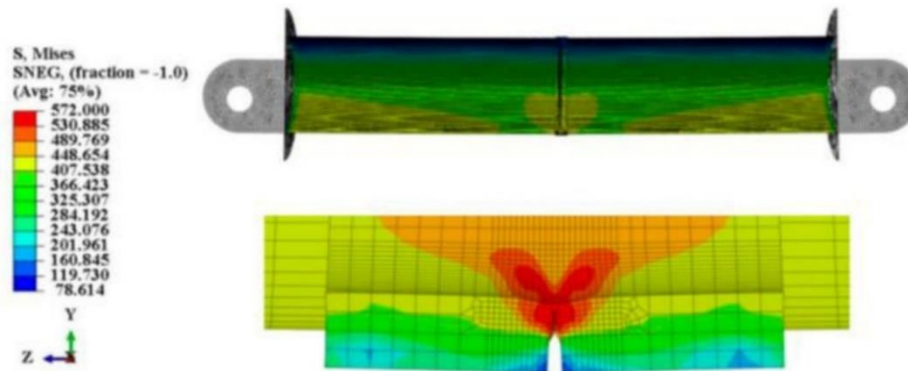
Figure 46 The CMOD failure[75]

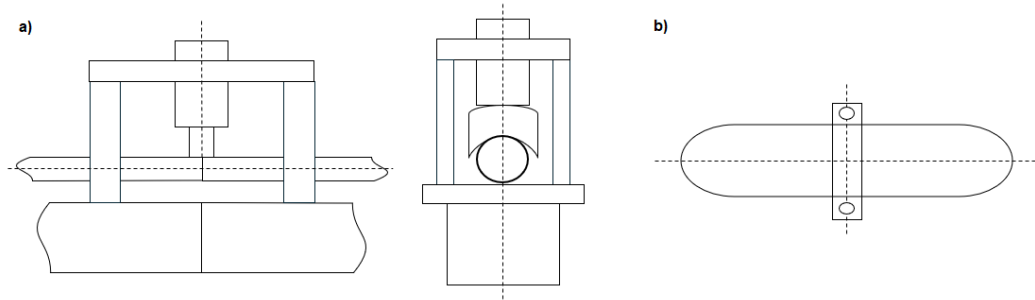
*Figure 54 The structure of the load transfer*

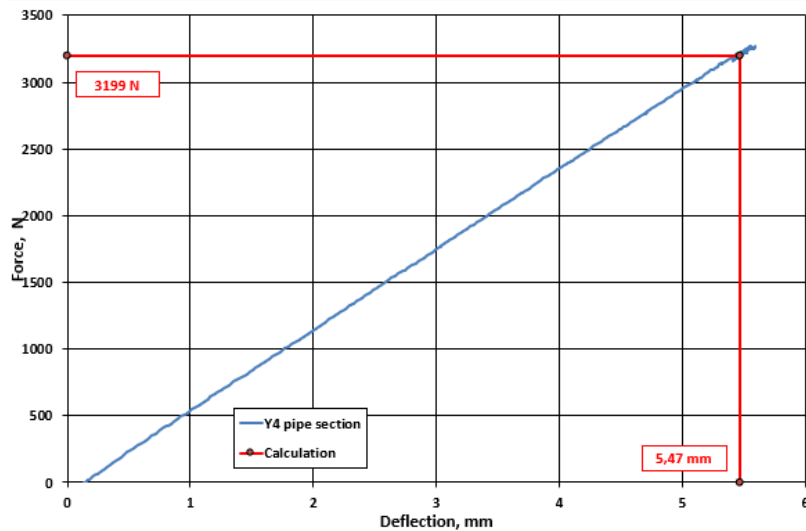
Figure 57 Calculation of the bending force on the experimental pipe section Y4

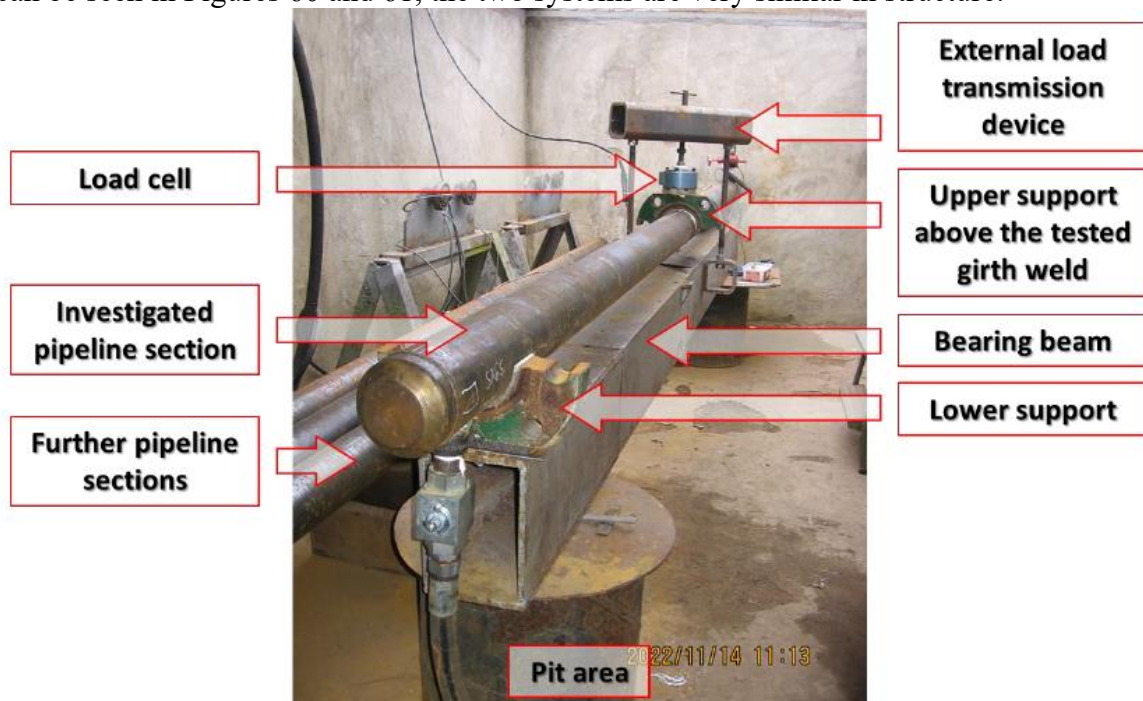
Figure 62 The pit area of our developed system with a pipeline section.

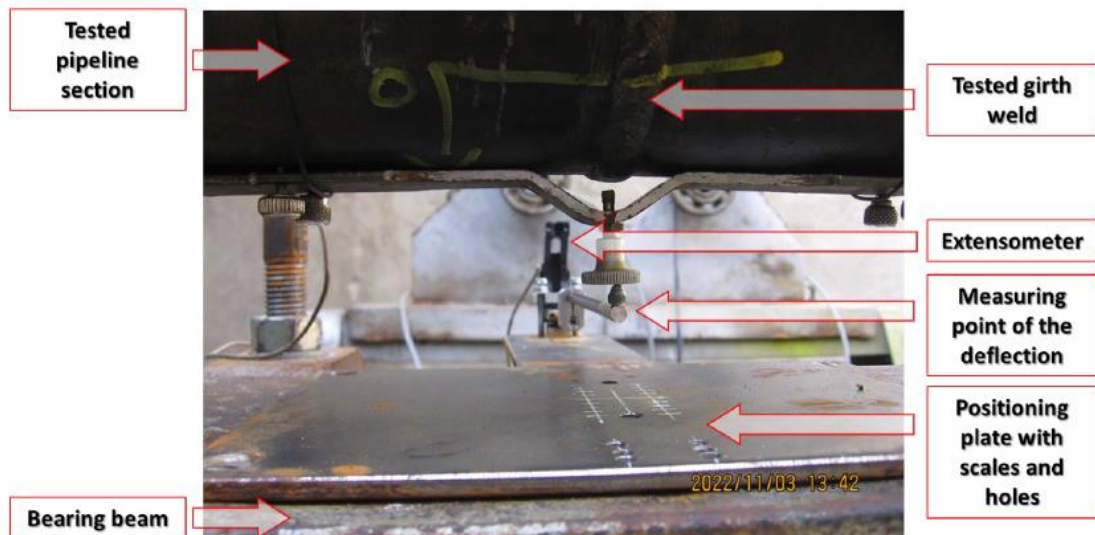
Figure 64 The positioning plate with scales and holes, and the measurement of the deflection by extensometer with extended arm.

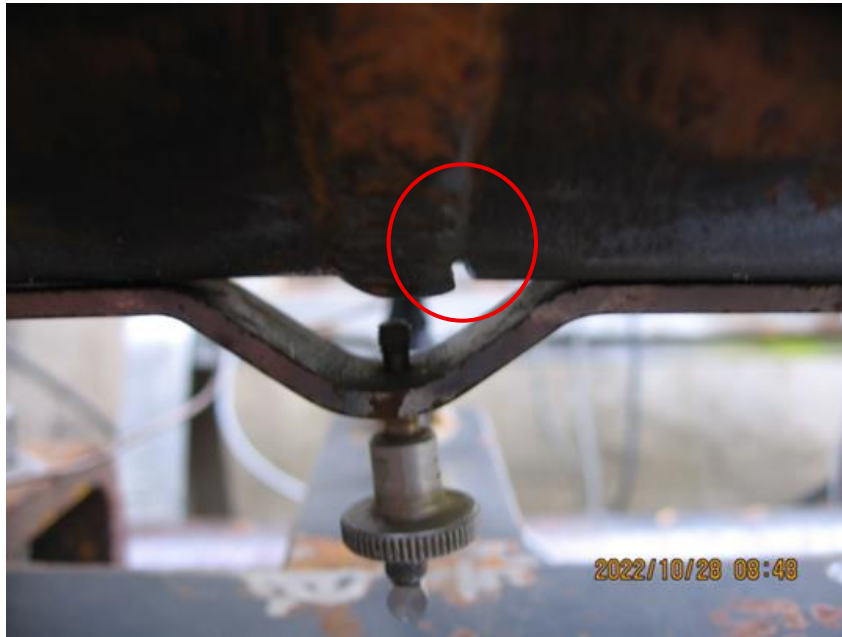
*Figure 65 The artificial notch configurations*

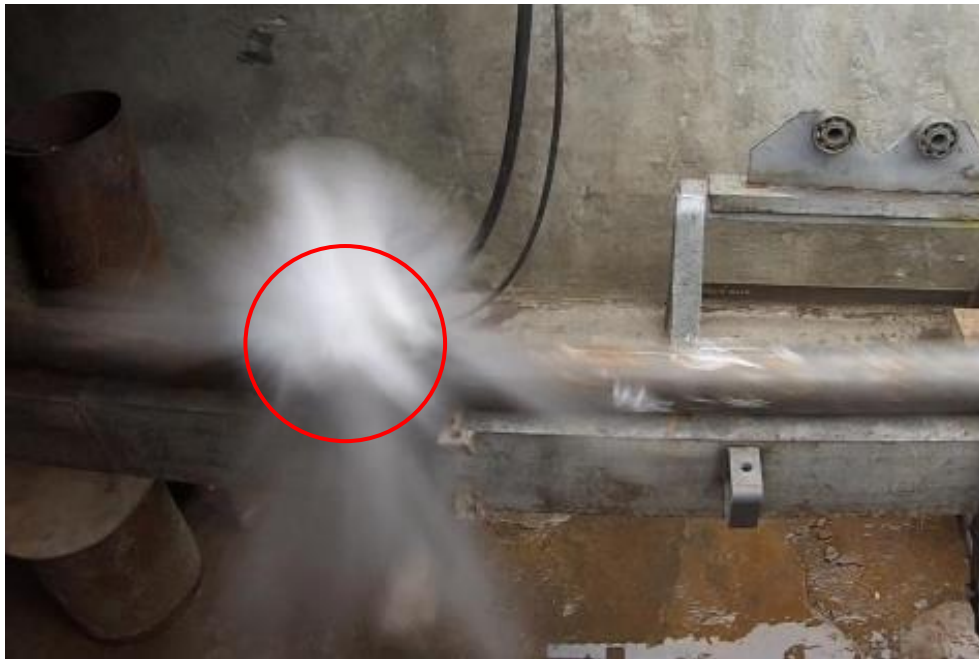
*Figure 74 Y1 pipeline section at the moment of its failures*

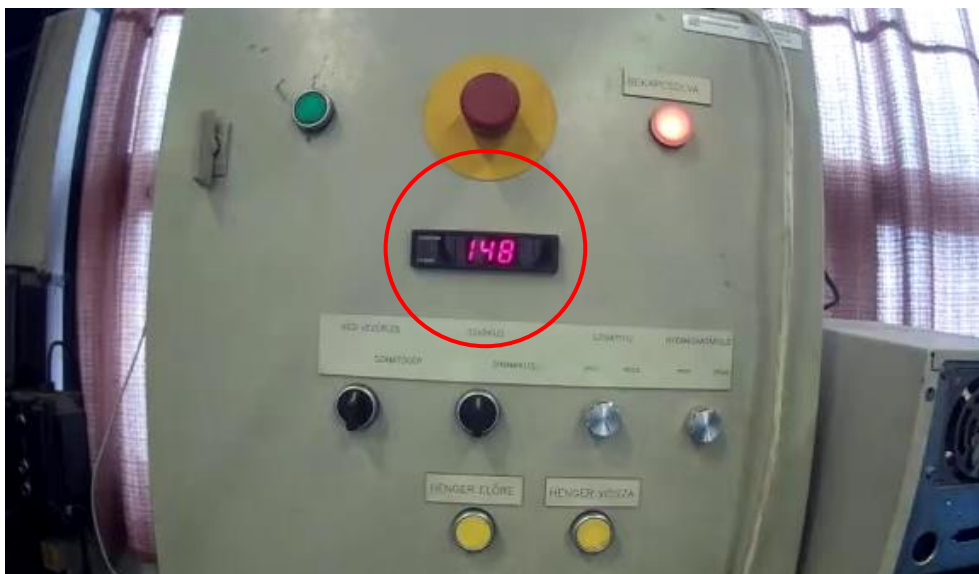
*Figure 75 The pressure value during the burst test (example)*

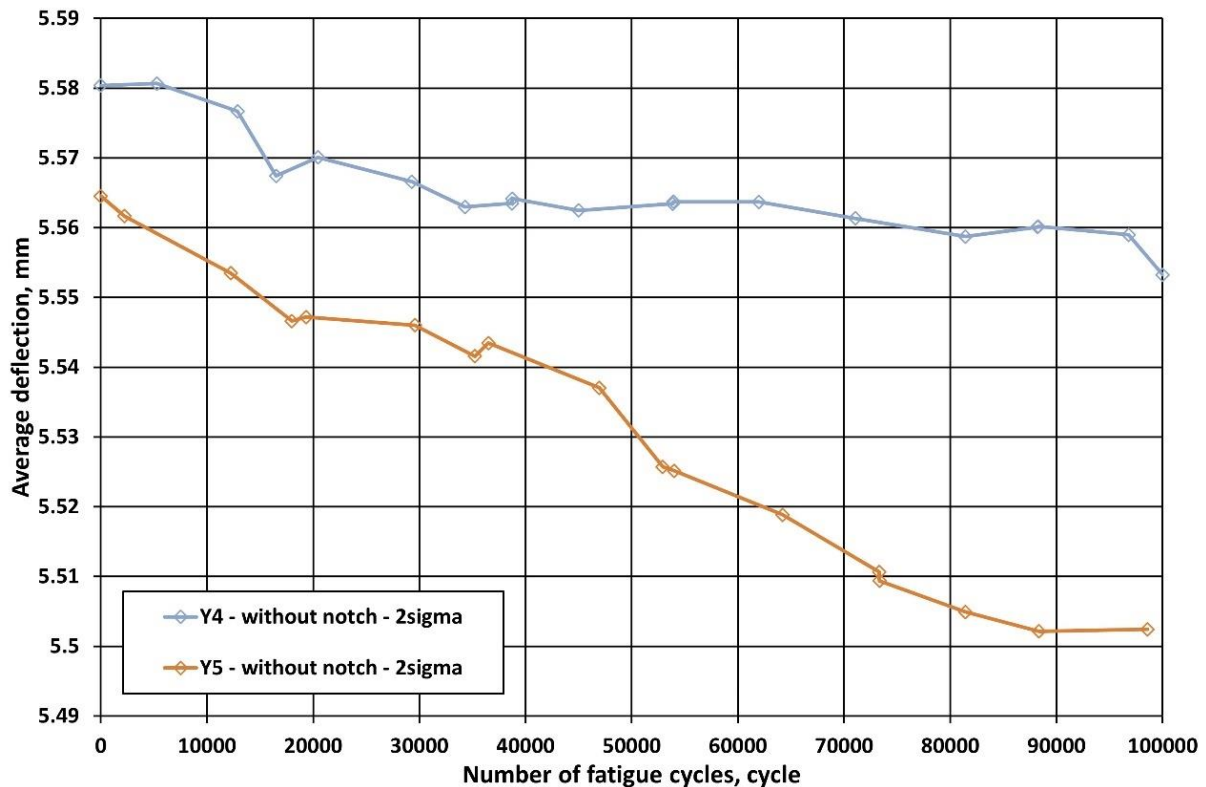
Figure 76 Average deformation (deflection) values and their variation during fatigue tests under minimal external bending load (Y4 and Y5 pipe sections,  $2\sigma_a$ )

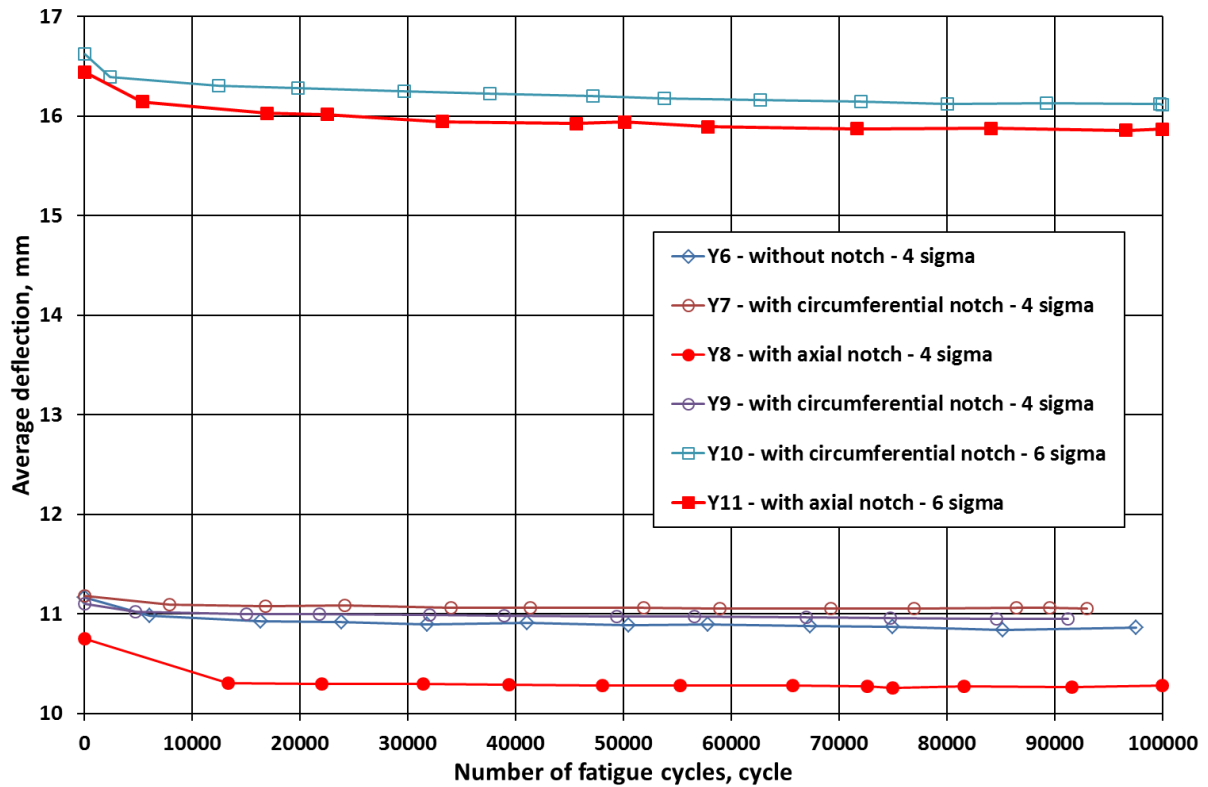
Figure 77 Average deformation (deflection) values and their variation during fatigue tests under intermediate external bending loads (Y6-Y11,  $4\sigma_a$  and  $6\sigma_a$ )

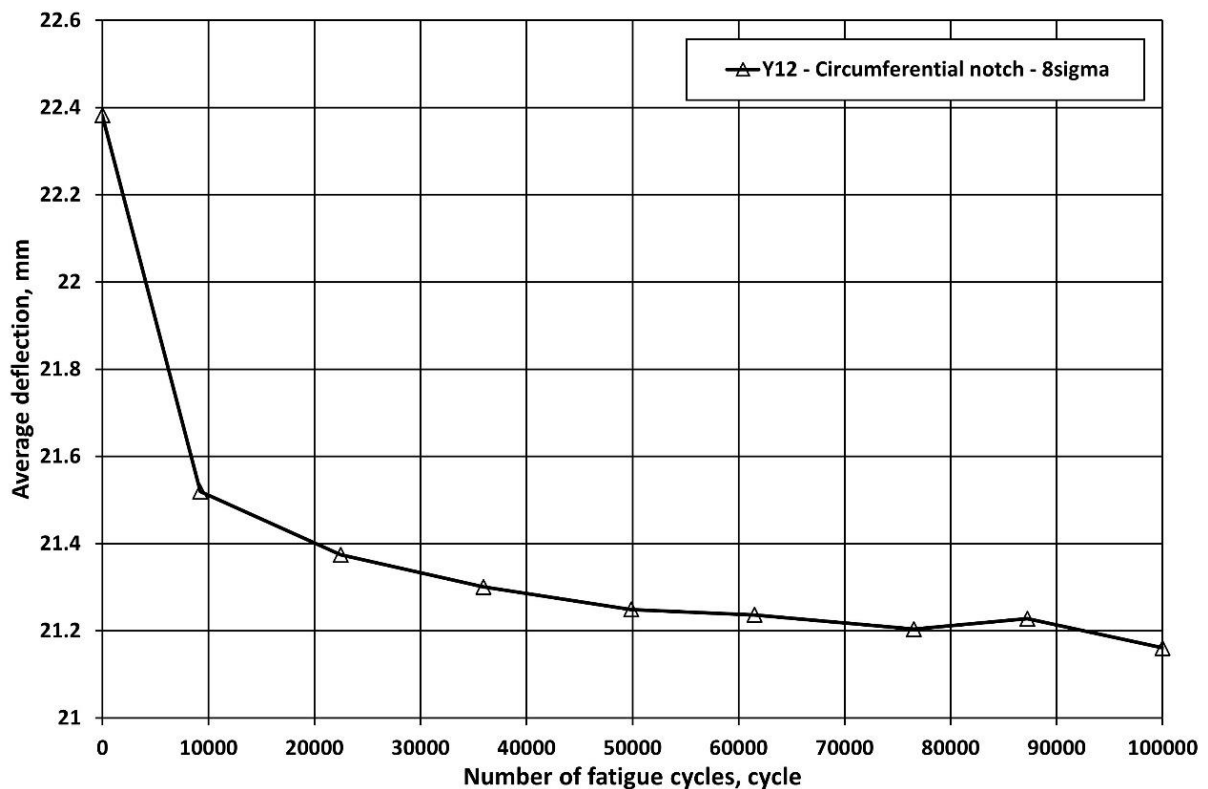
Figure 78 Average deformation (deflection) values and their variation during fatigue tests under maximal external bending load (Y12 pipe section,  $8\sigma_a$ )
