**INTEGRITY OF TRANSPORTING PIPELINE GIRTH WELDS BASED  
ON FULL-SCALE TESTS UNDER COMPLEX LOADING  
CONDITIONS**

PHD THESES

**Ahmad Yasser Dakhel**

**Miskolc  
2025**

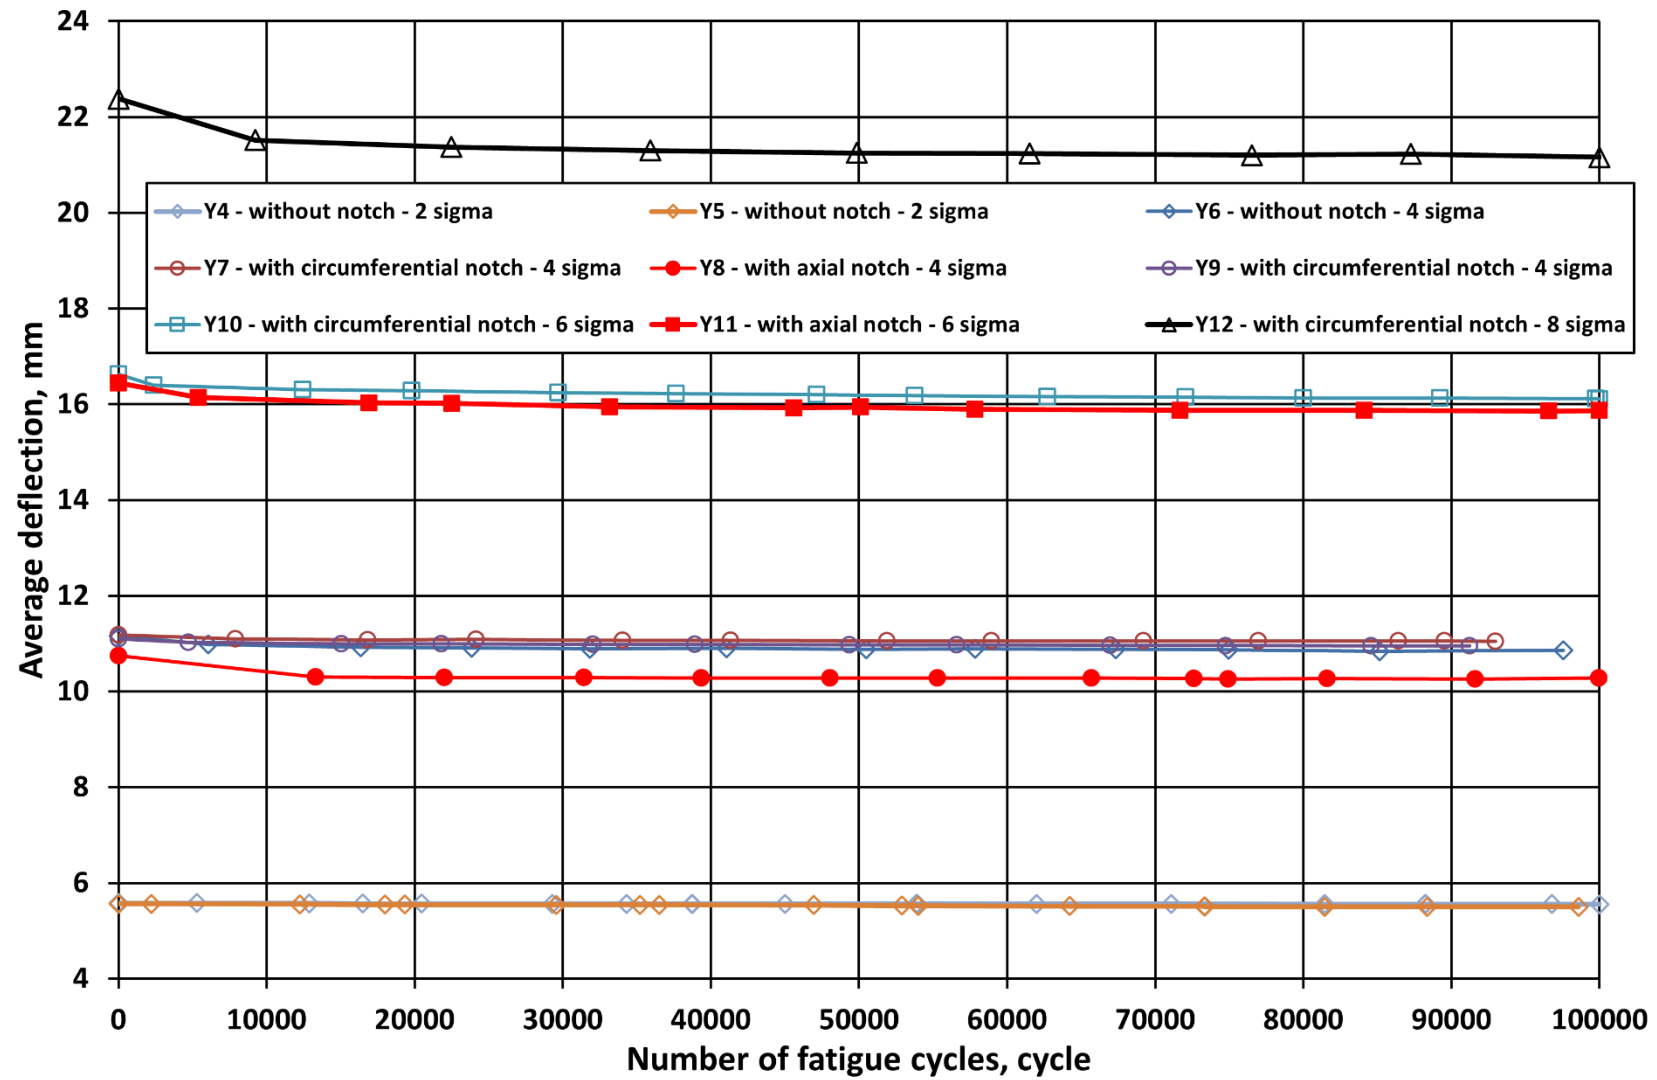
Figure 79 Average deflection values and their changes during the fatigue tests: all pipeline sections

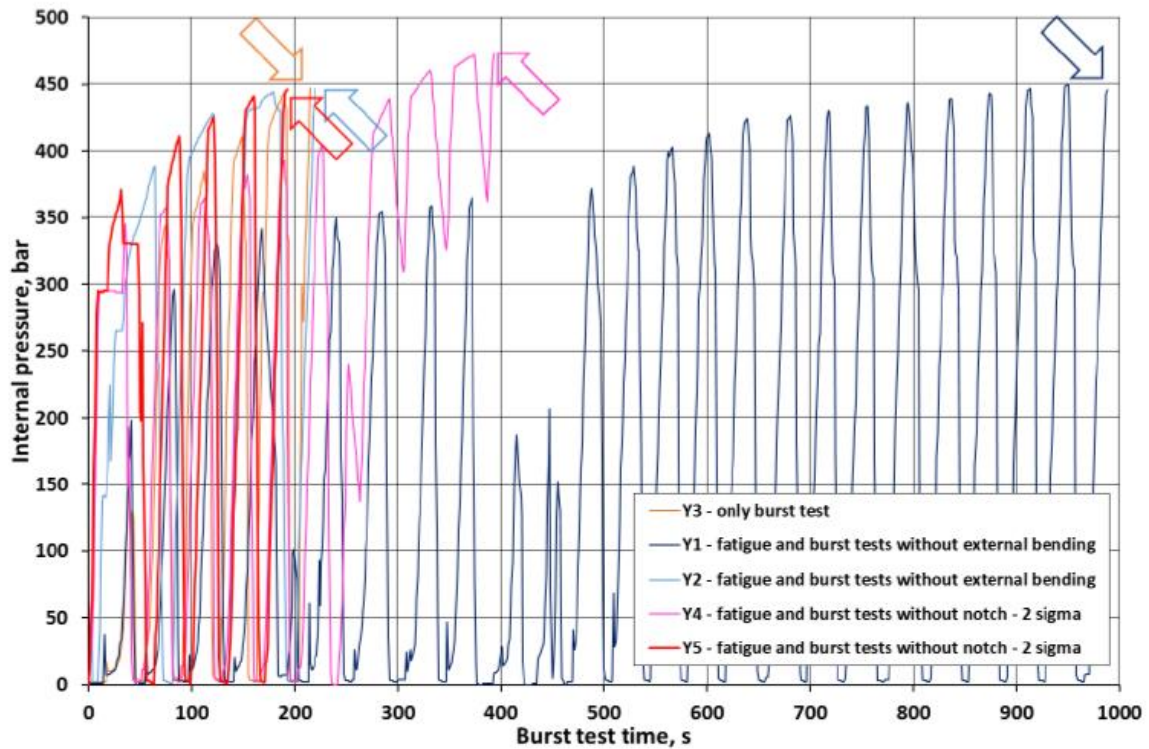
Figure 80 Internal pressure vs. burst test time diagrams of the investigated Y1-Y5 pipeline sections

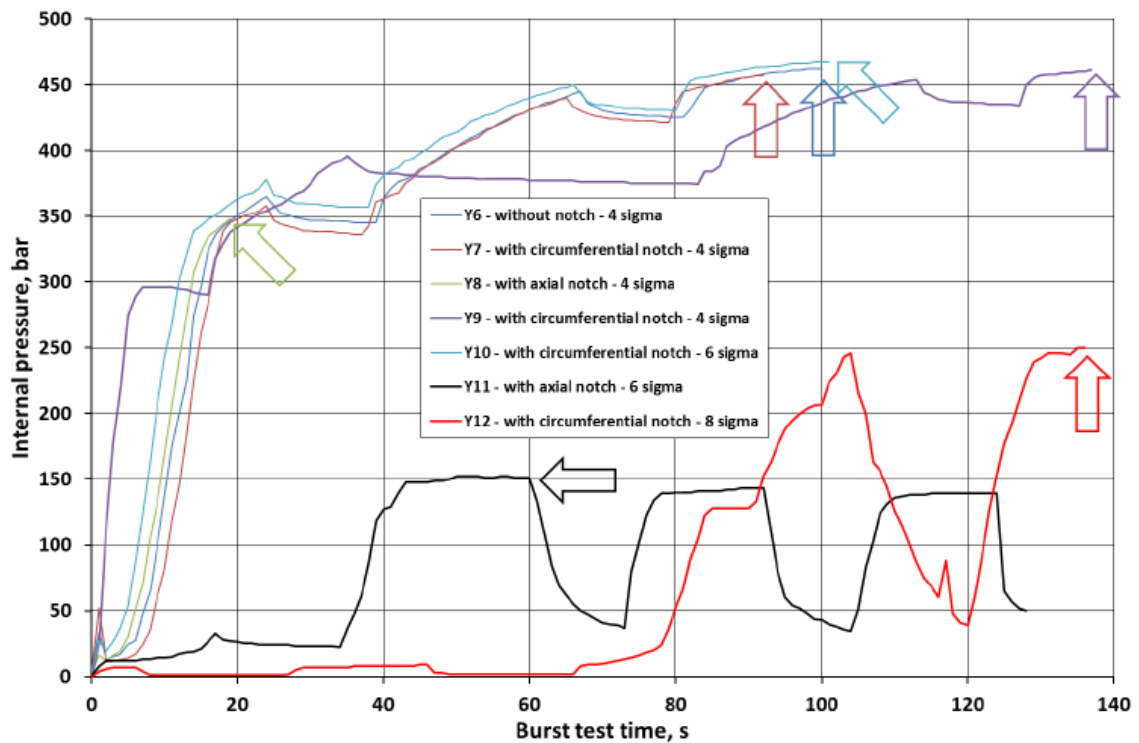
Figure 81 Internal pressure vs. burst test time diagrams of the investigated Y6-Y12 pipeline sections

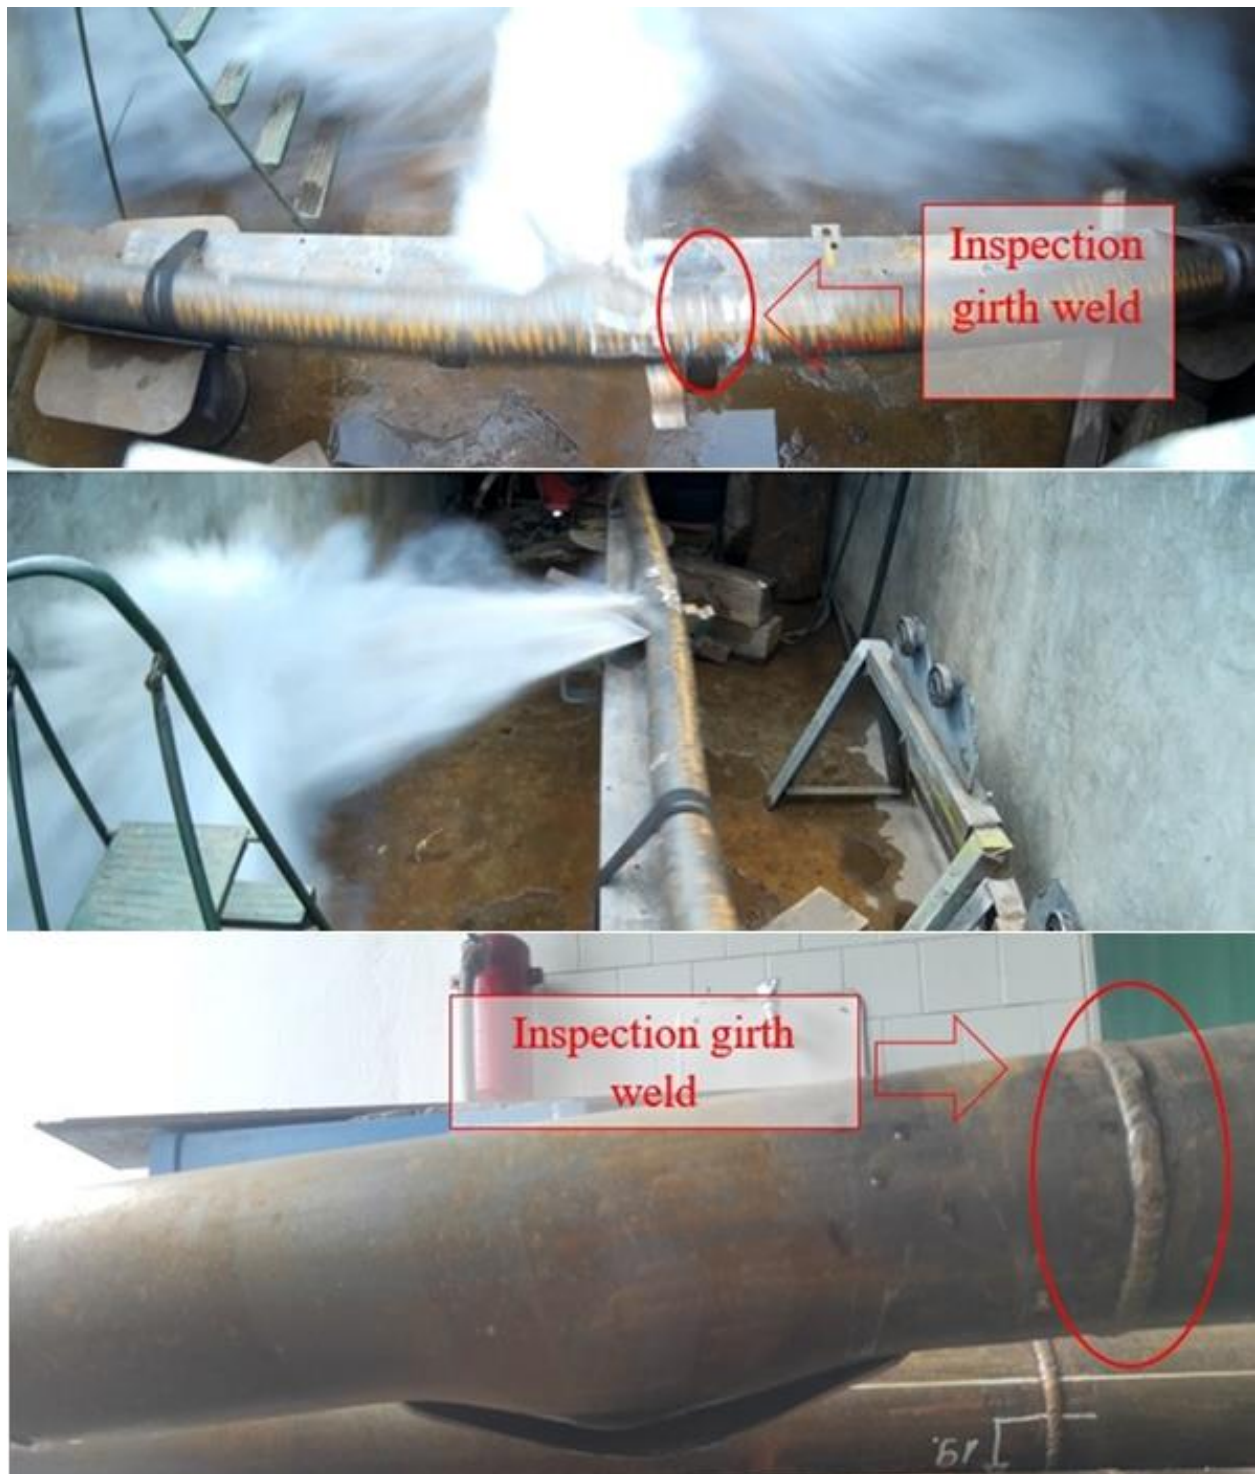
*Figure 82 Moment of failure of the pipeline section Y3 during the burst test: side view (top), longitudinal view (middle), the Y3 pipeline section after the burst test: the damaged section and the tested girth weld (bottom)*

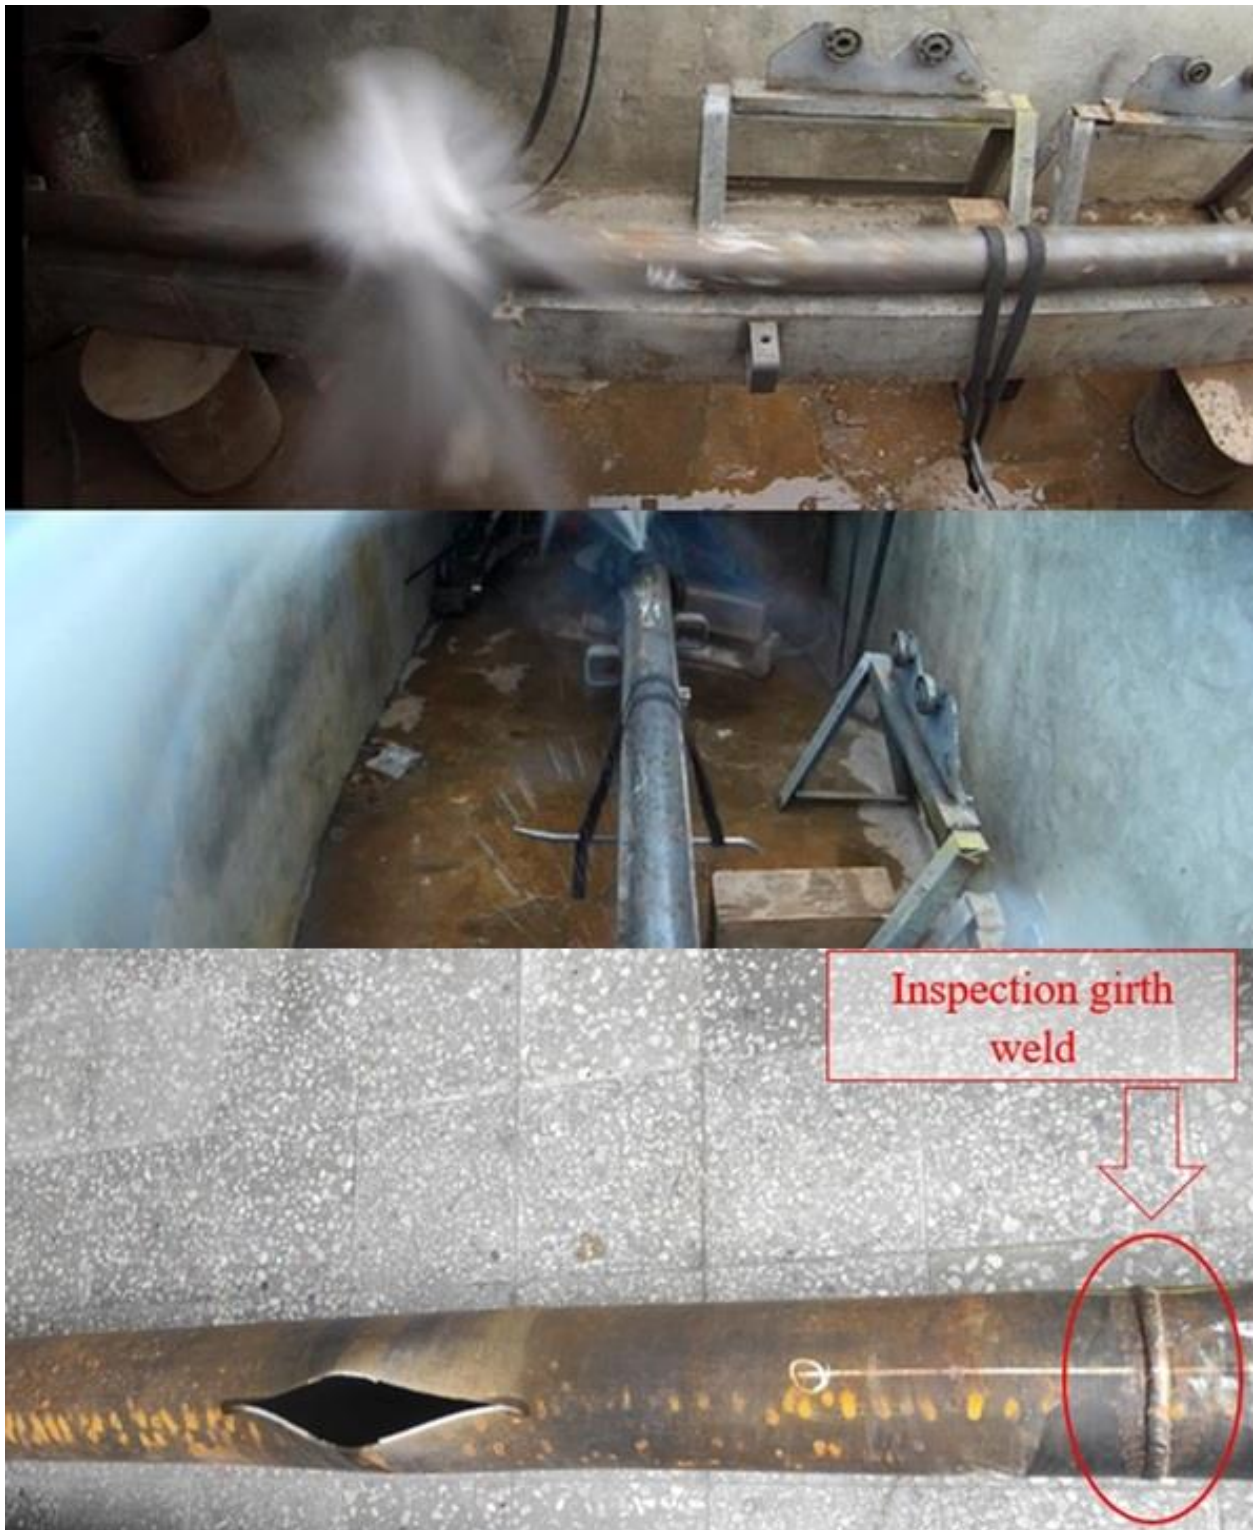
*Figure 83 Moment of failure of the pipeline section Y1 during the burst test: side view (top), longitudinal view (middle), the Y1 pipeline section after the burst test: the damaged section and the tested girth weld (bottom)*

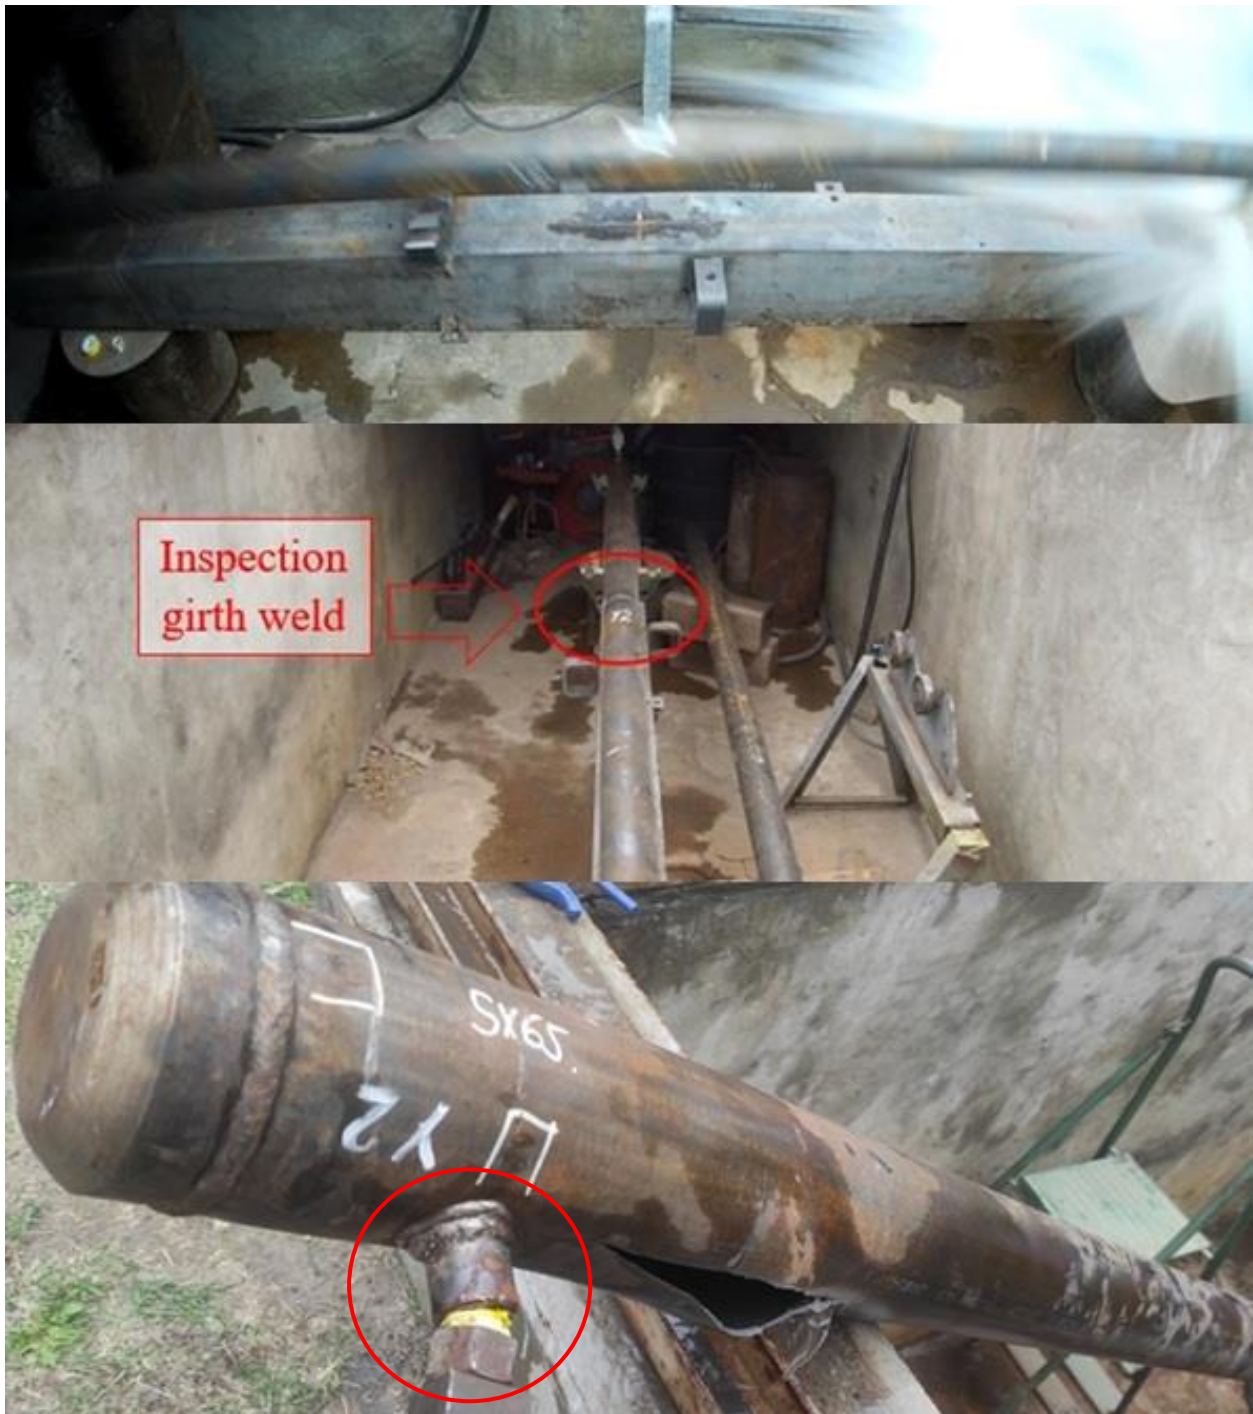
*Figure 84 Moment of failure of the pipeline section Y2 during the burst test: side view (top), longitudinal view (middle), the pipeline section Y2 after the burst test: the pipeline section with the damaged section (and the damaged coupling fitting highlighted with red circle) partially ejected from the test pit (bottom)*

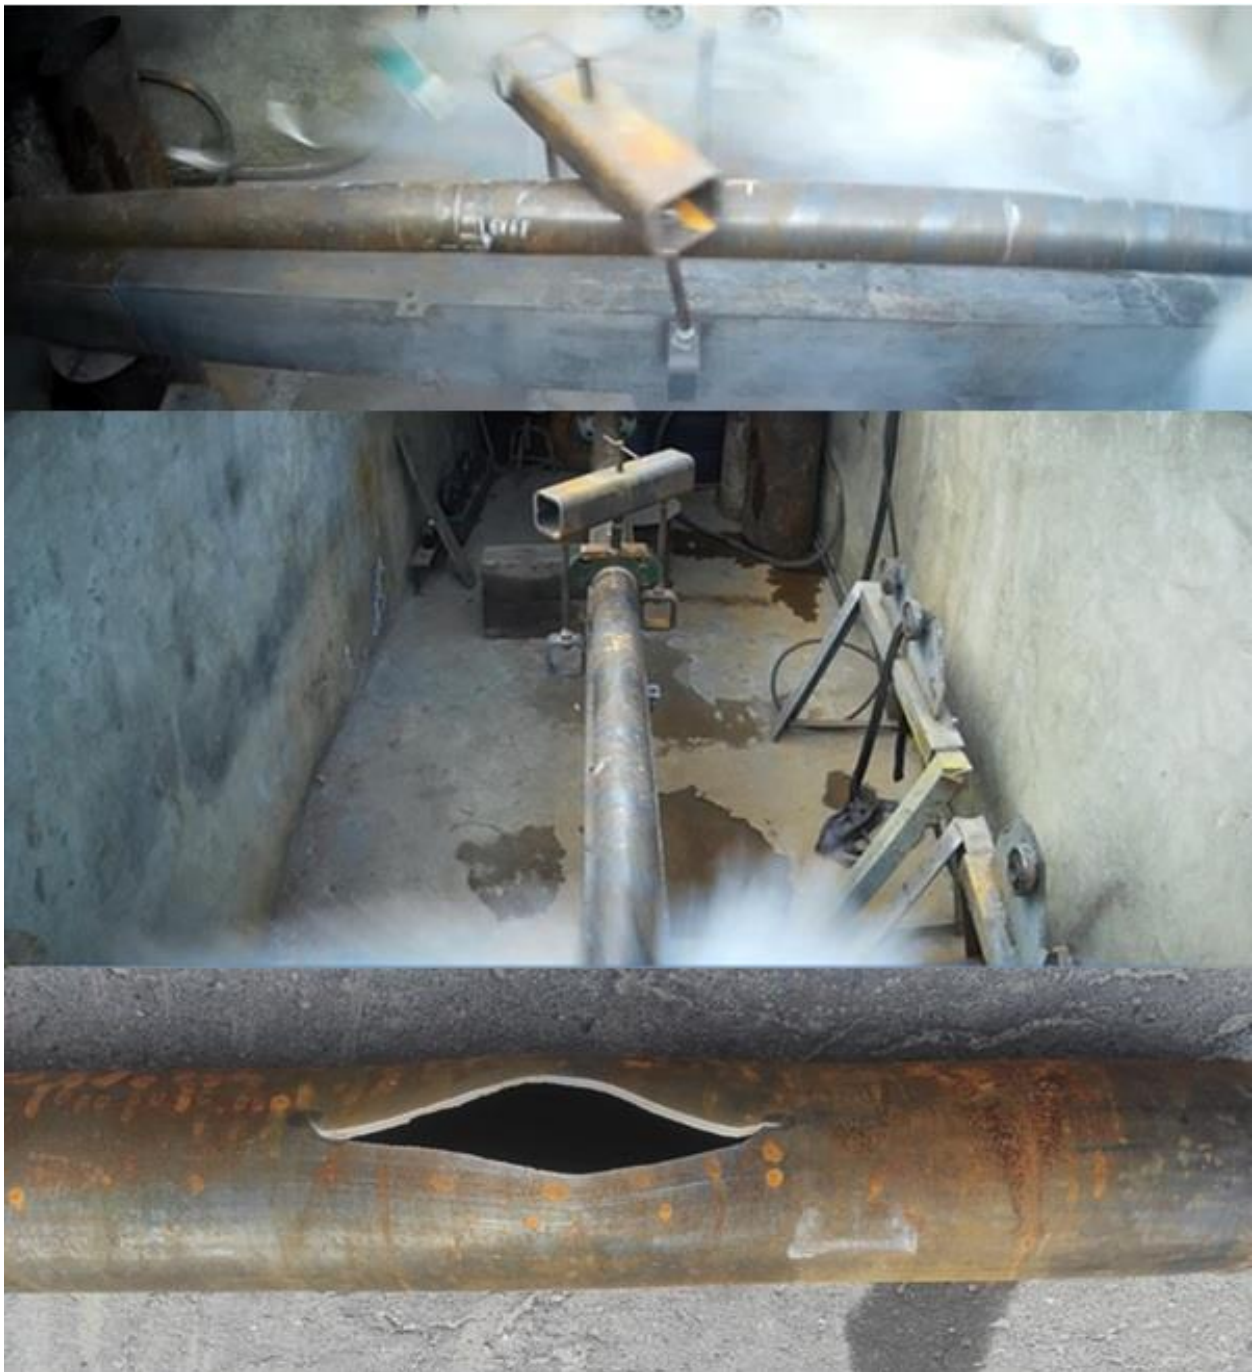
*Figure 85 Moment of failure of the pipeline section Y4 during the burst test: side view (top), longitudinal view (middle), the pipeline section Y4 after the burst test: the damaged section (bottom)*

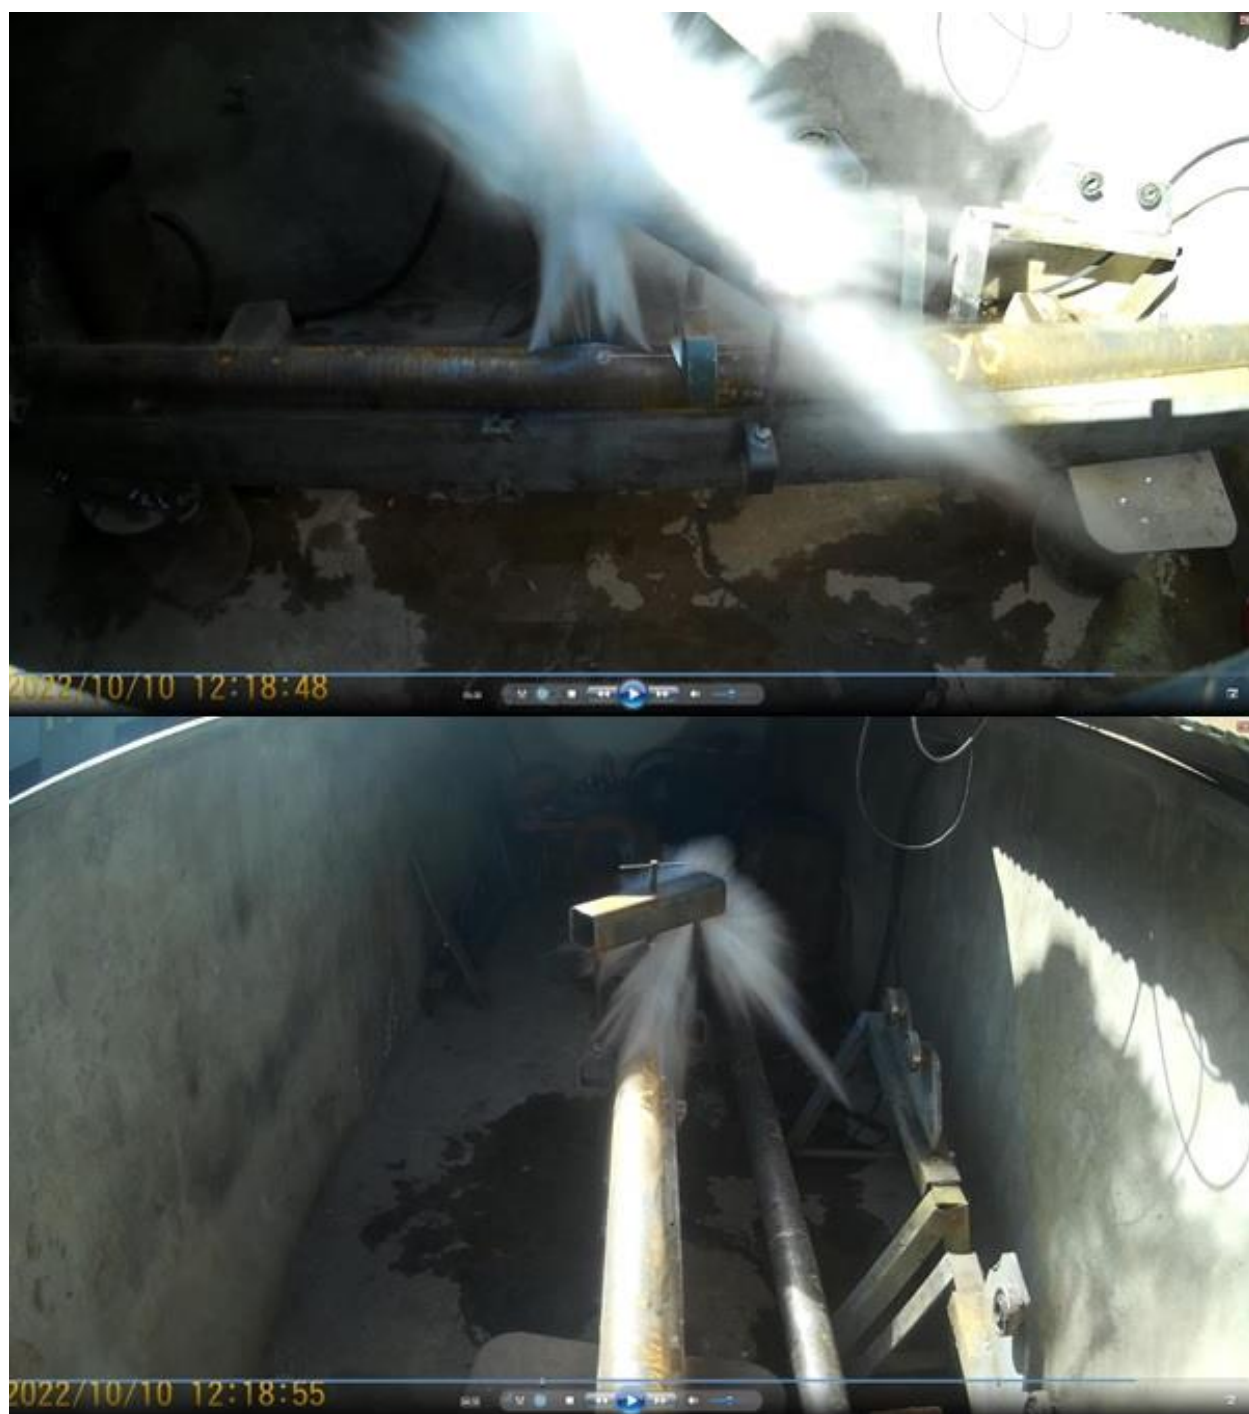
*Figure 86 Moment of failure of the pipeline section Y5 during the burst test: side view (top), longitudinal view (bottom)*

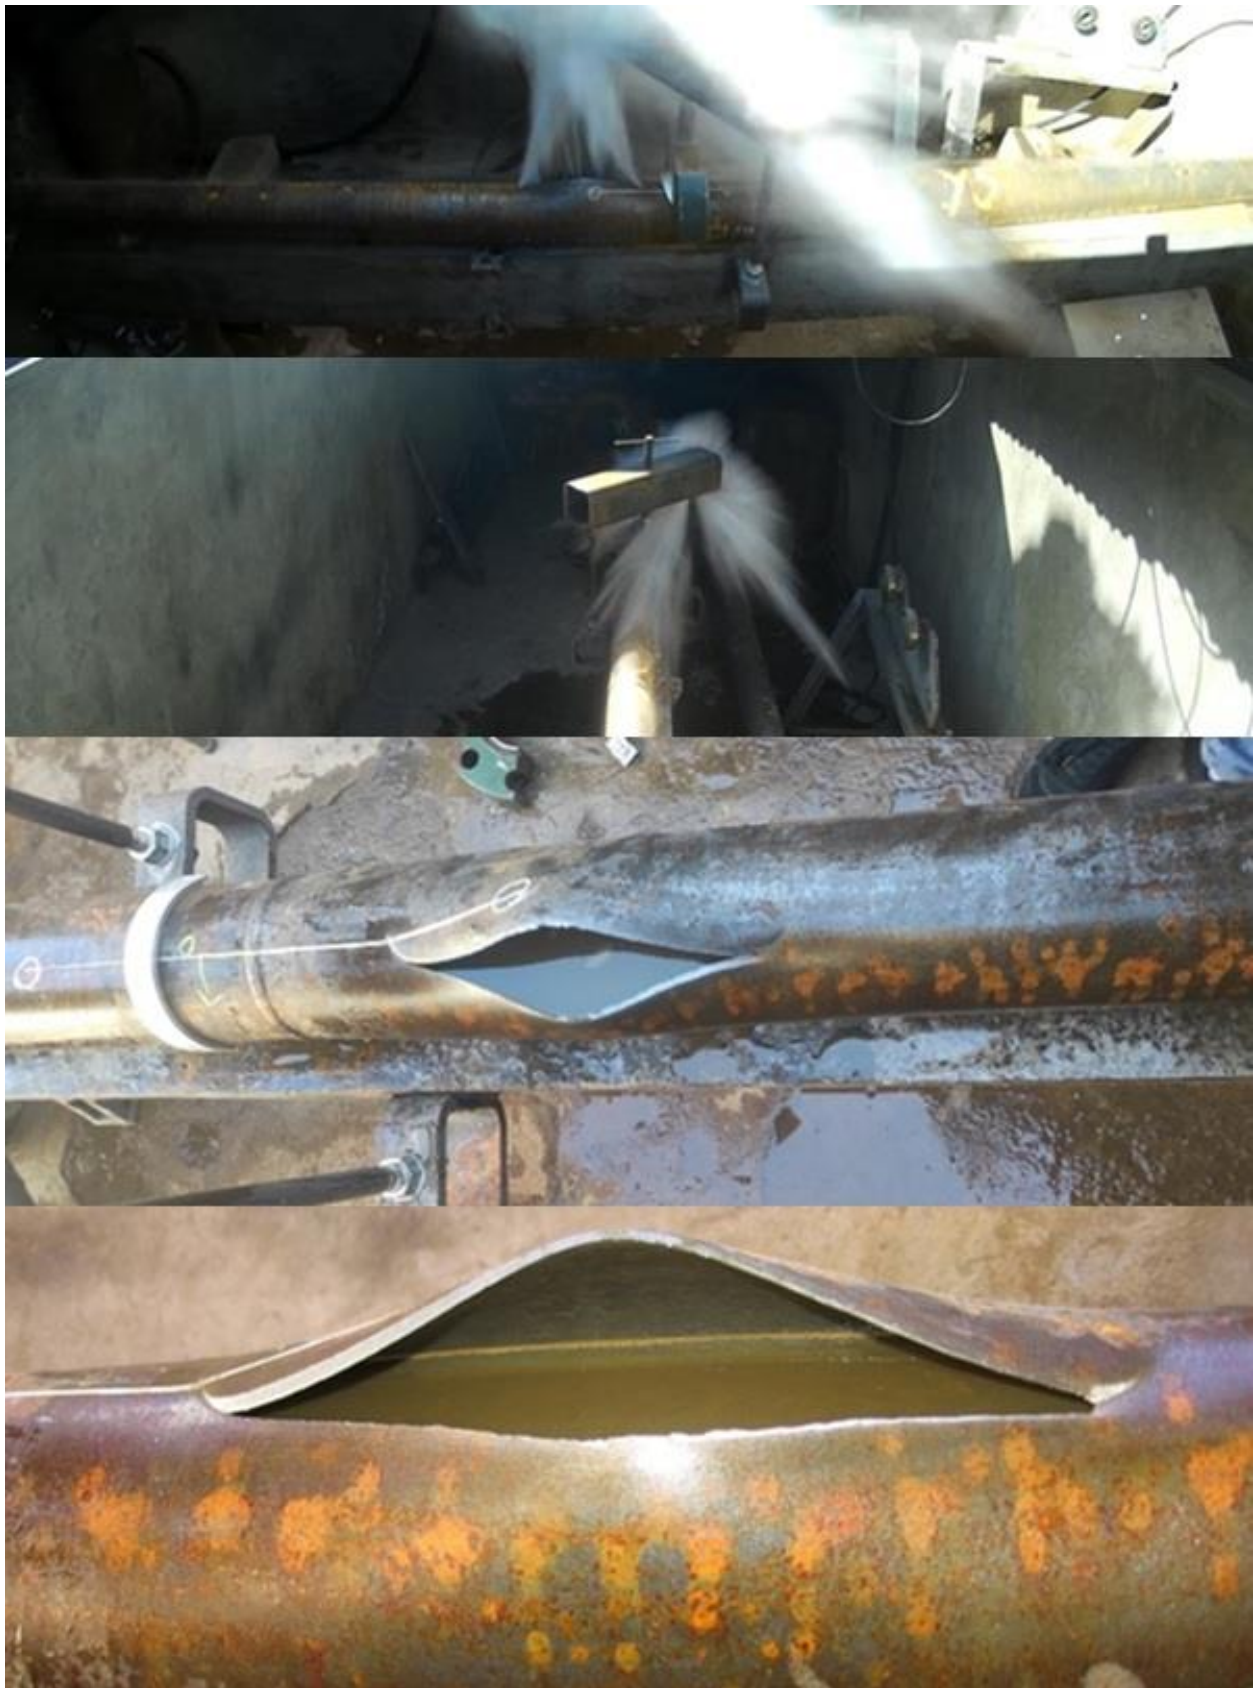
*Figure 87 Pipeline section Y5 after the burst test: pipe section displaced on the support beam in the test pit (top), damaged section (second), moment of failure of the pipeline section Y6 during the burst test: side view (third), longitudinal view (bottom)*

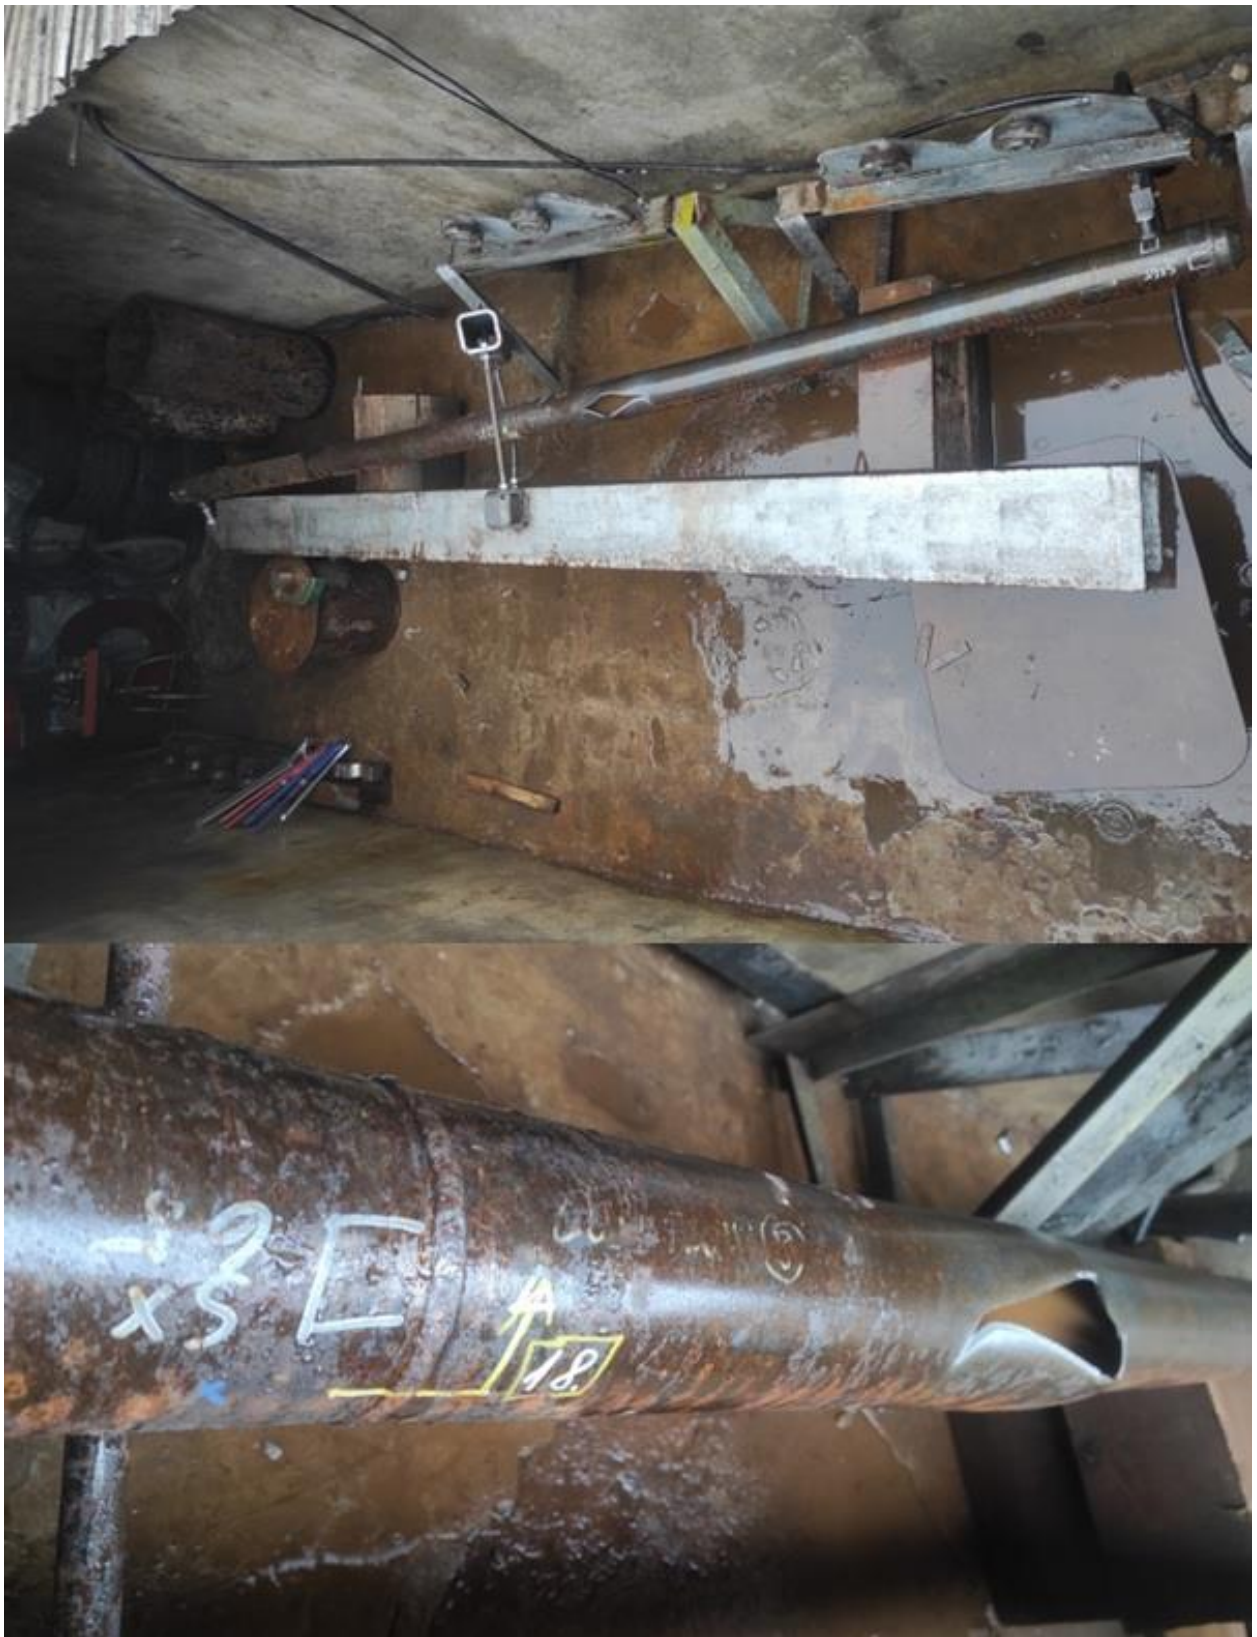
*Figure 88 Pipeline section Y6 after burst test: section of pipe (with the burst support beam and the damaged external load transfer device) in the test pit (top), damaged section (bottom)*

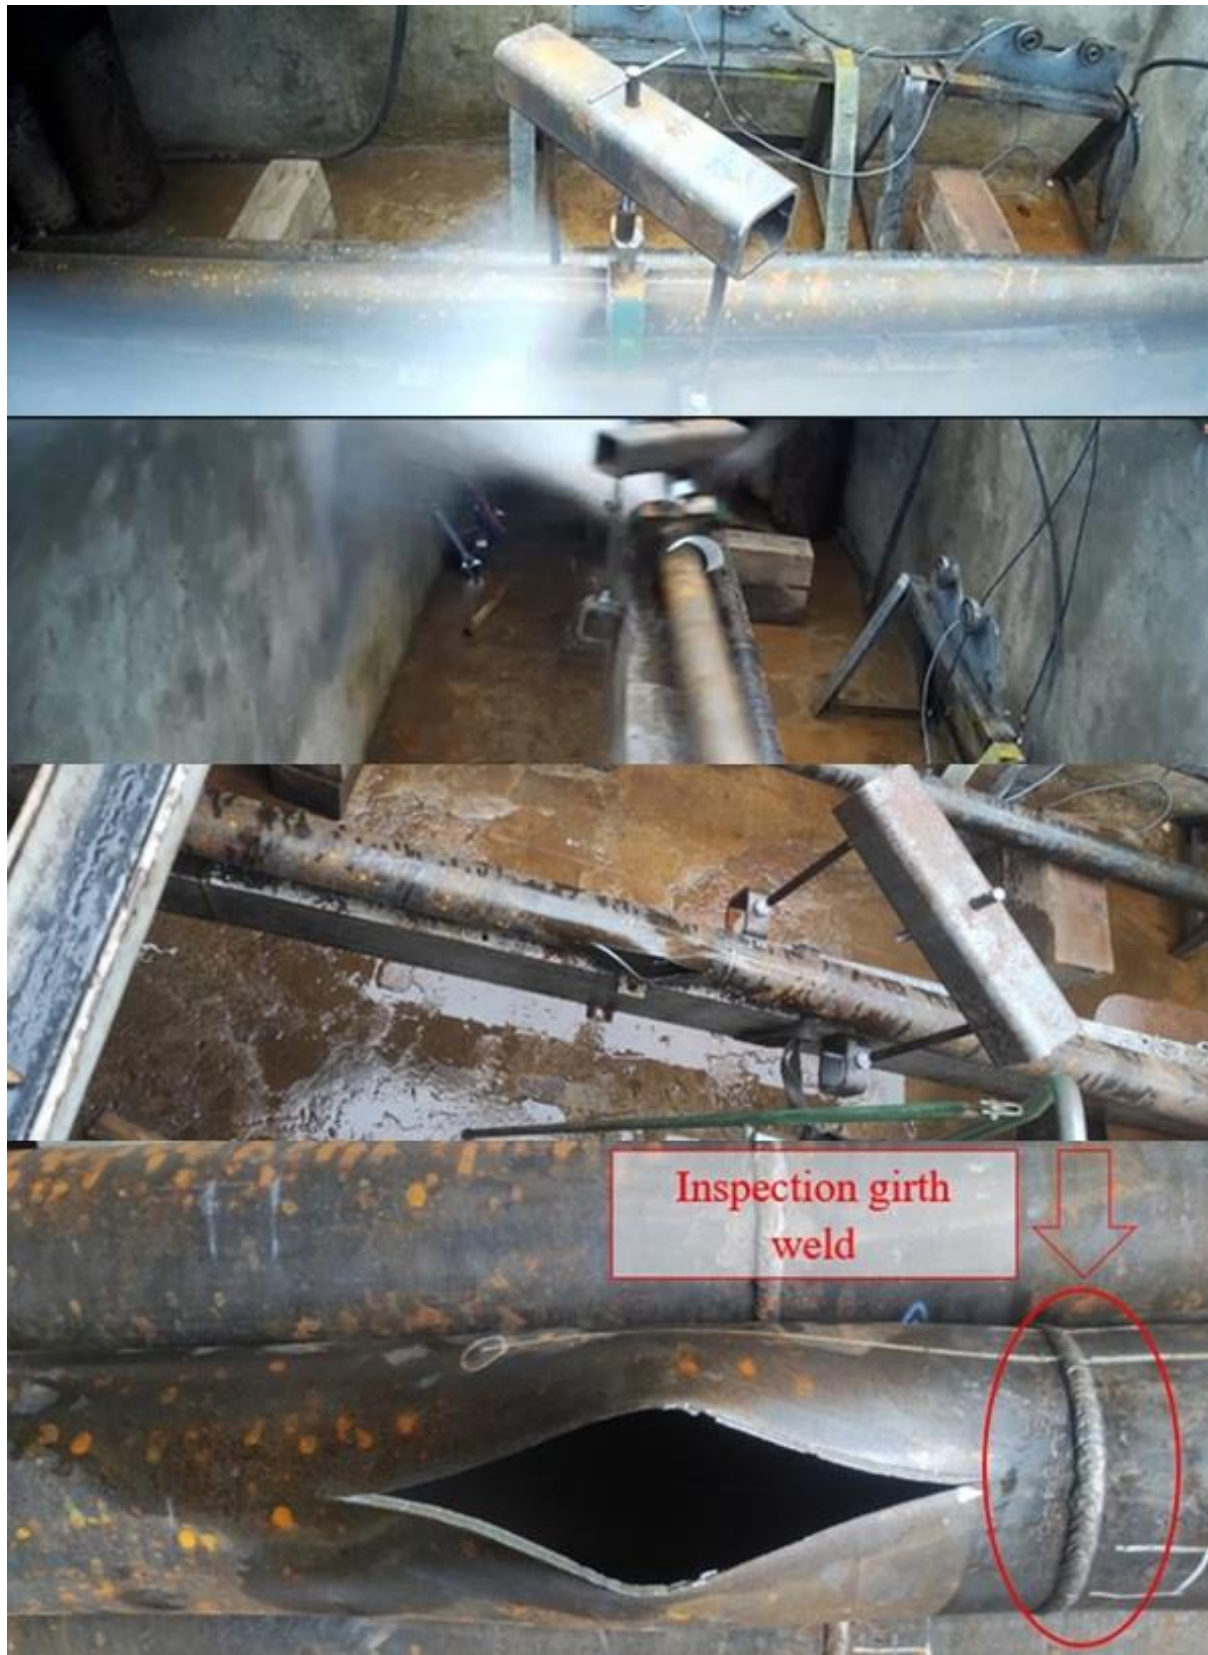
Figure 89 Moment of failure of the pipeline section Y7 during the burst test: side view (top), longitudinal view (second), the pipeline section Y7 after failure: the pipeline section displaced on the supporting beam (and the damaged external load transfer structure) in the test pit (third), the damaged section (bottom)

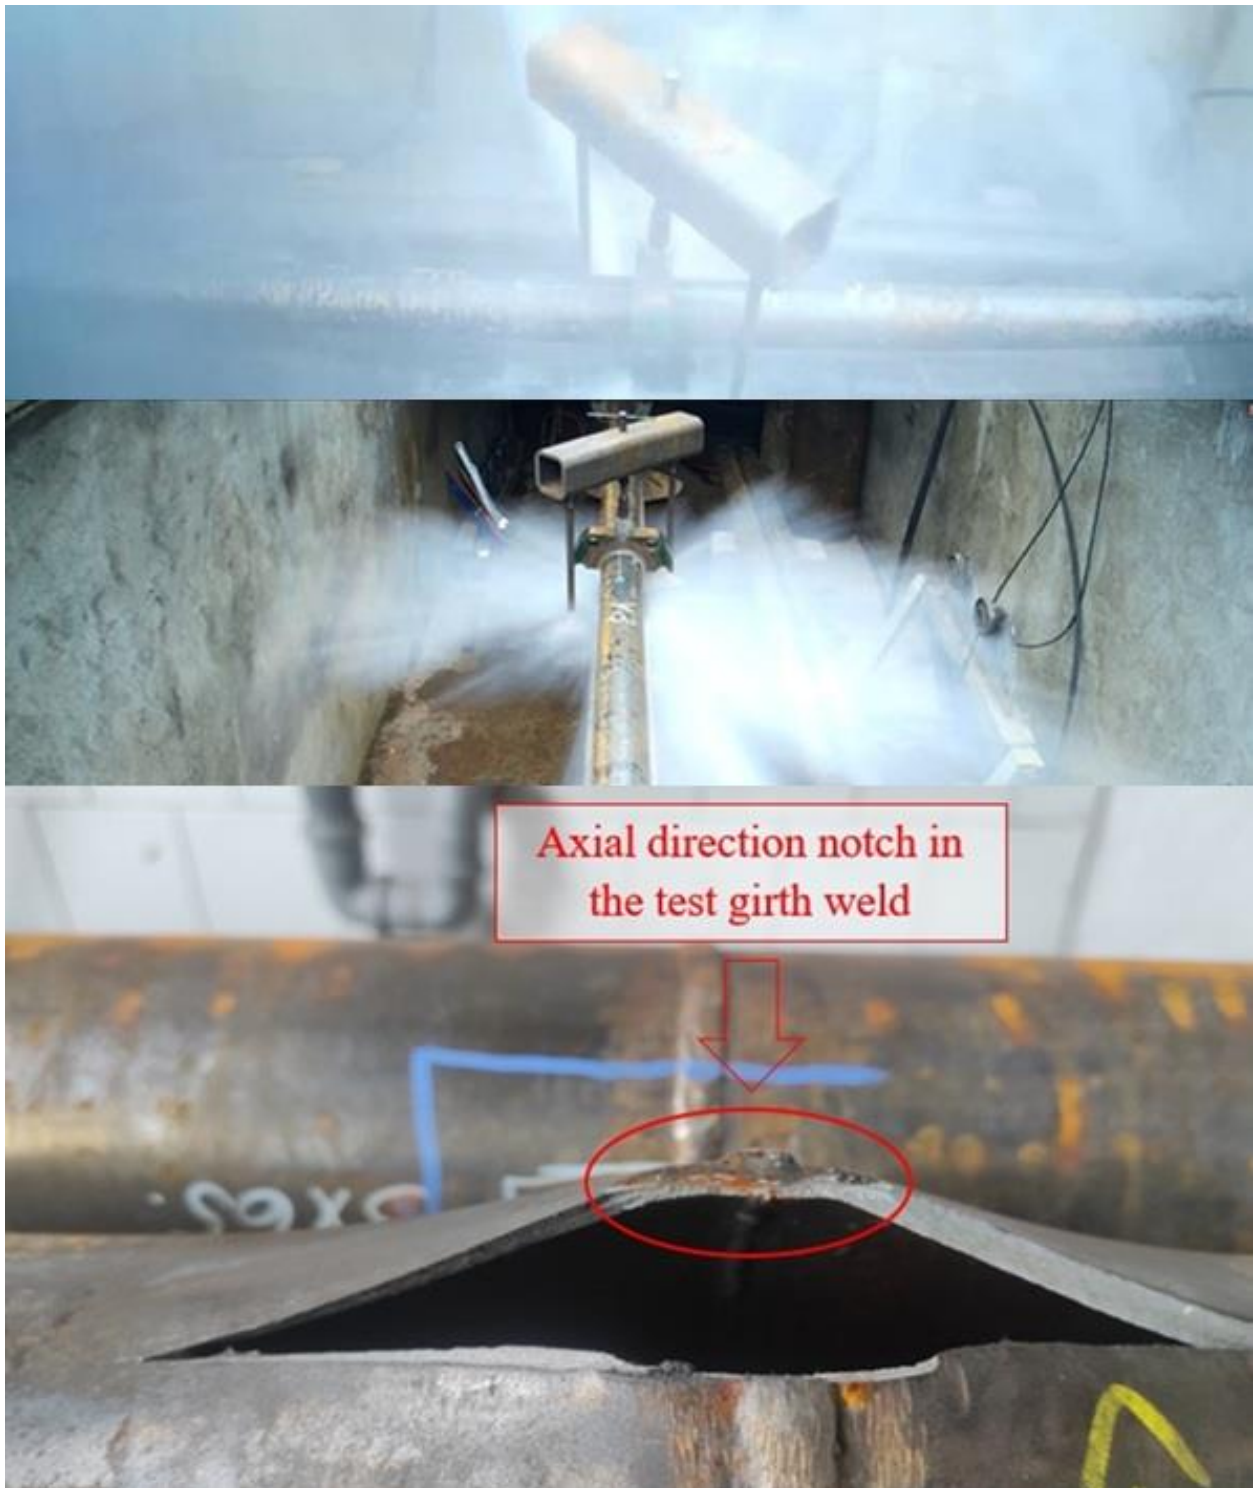
*Figure 90 Moment of failure of the pipeline section Y8 during the burst test: side view (top), longitudinal view (middle), the pipeline section Y8 after failure: the damaged area with axial notch perpendicular to the girth weld (bottom)*

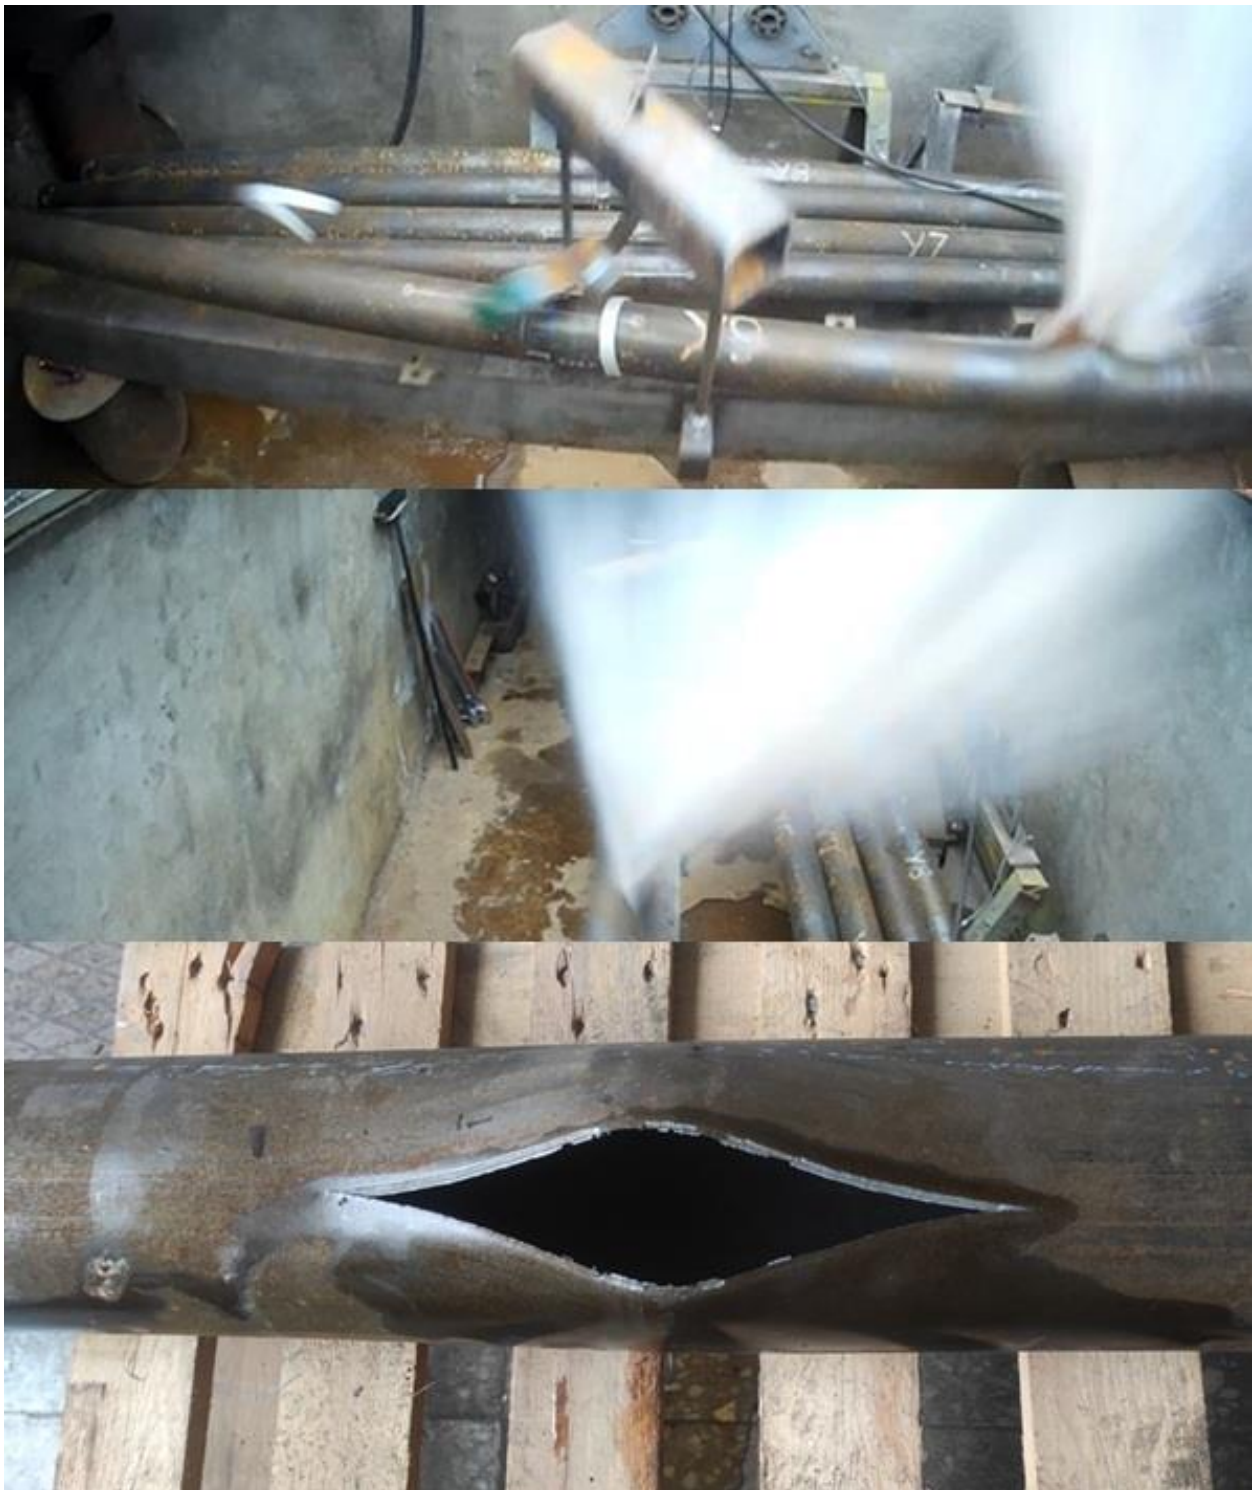
*Figure 91 Moment of failure of the pipeline section Y9 during the burst test: side view (top), longitudinal view (middle), the pipeline section Y9 after the burst test: the damaged section (bottom)*
