**INTEGRITY OF TRANSPORTING PIPELINE GIRTH WELDS BASED  
ON FULL-SCALE TESTS UNDER COMPLEX LOADING  
CONDITIONS**

PHD THESES

**Ahmad Yasser Dakhel**

**Miskolc  
2025**

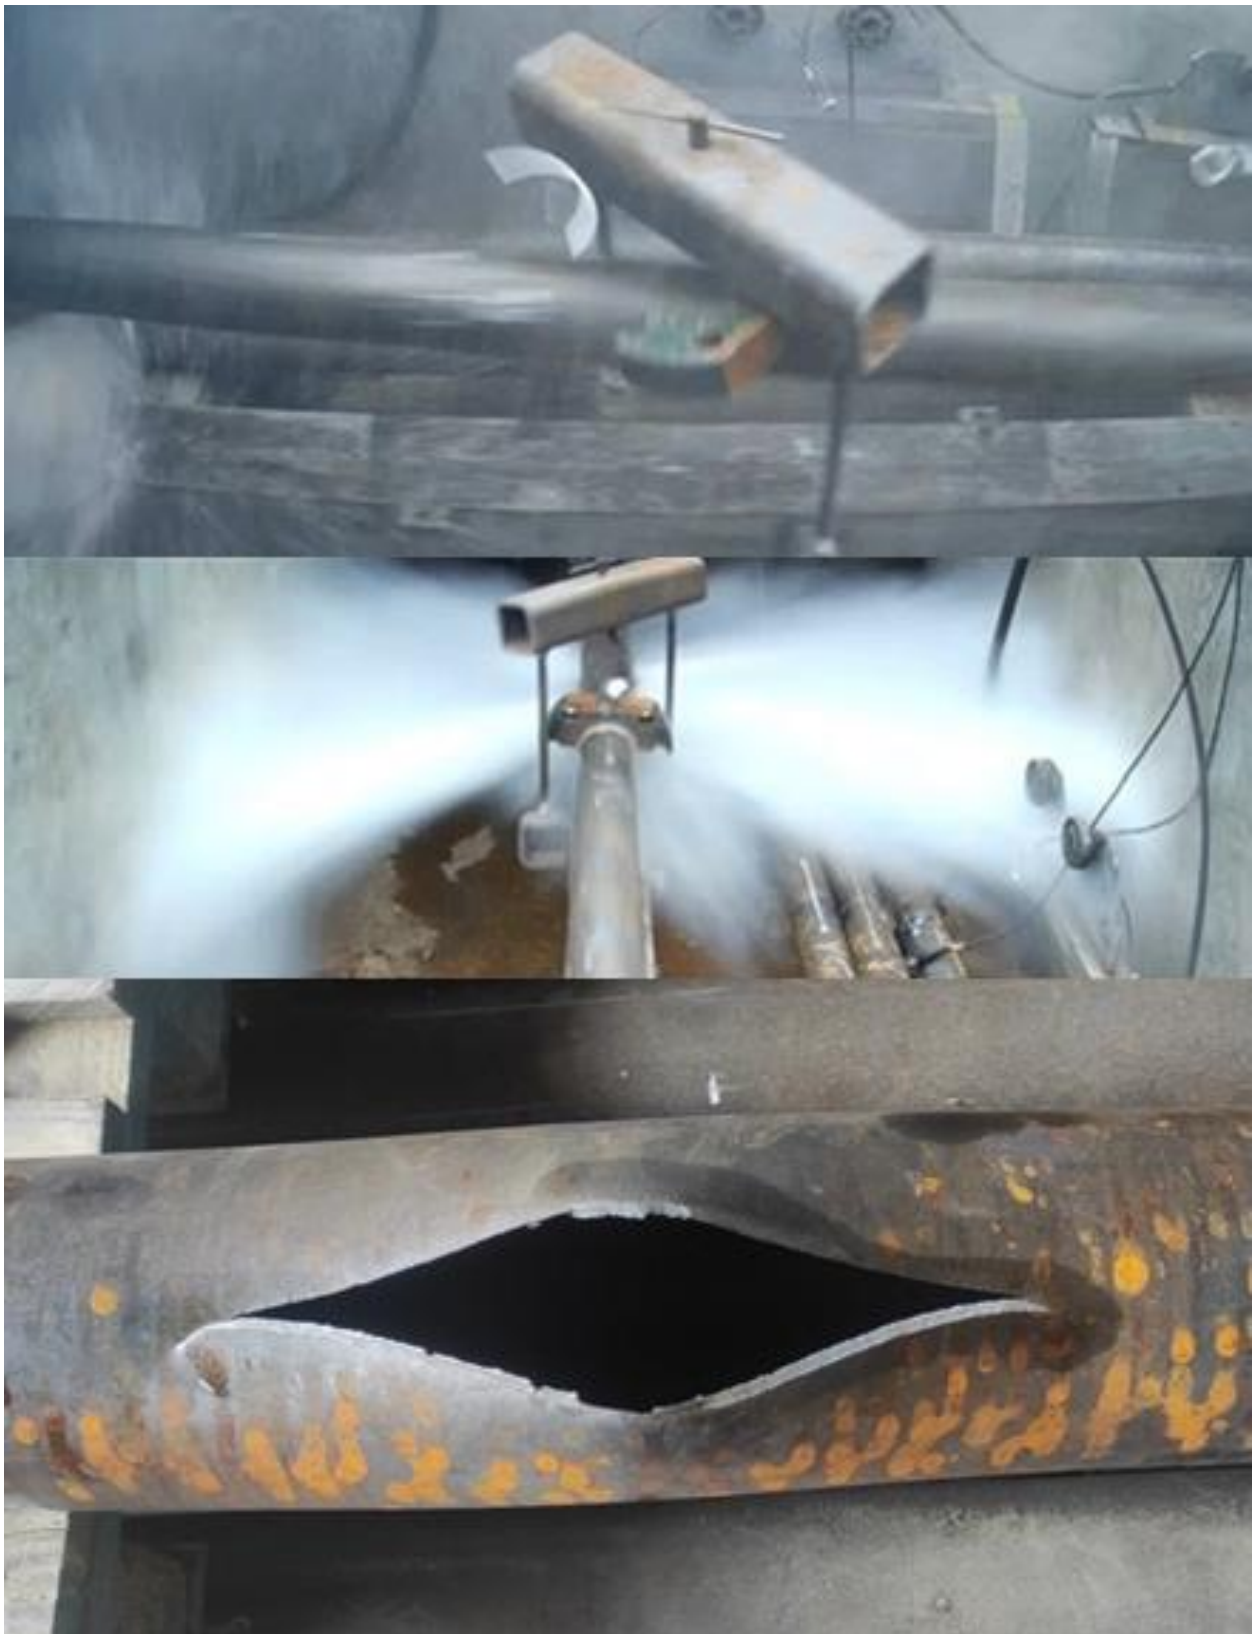
*Figure 92 Moment of failure of the pipeline section Y10 during the burst test: side view (top), longitudinal view (middle), the pipeline section Y10 after the burst test: the damaged section (bottom)*

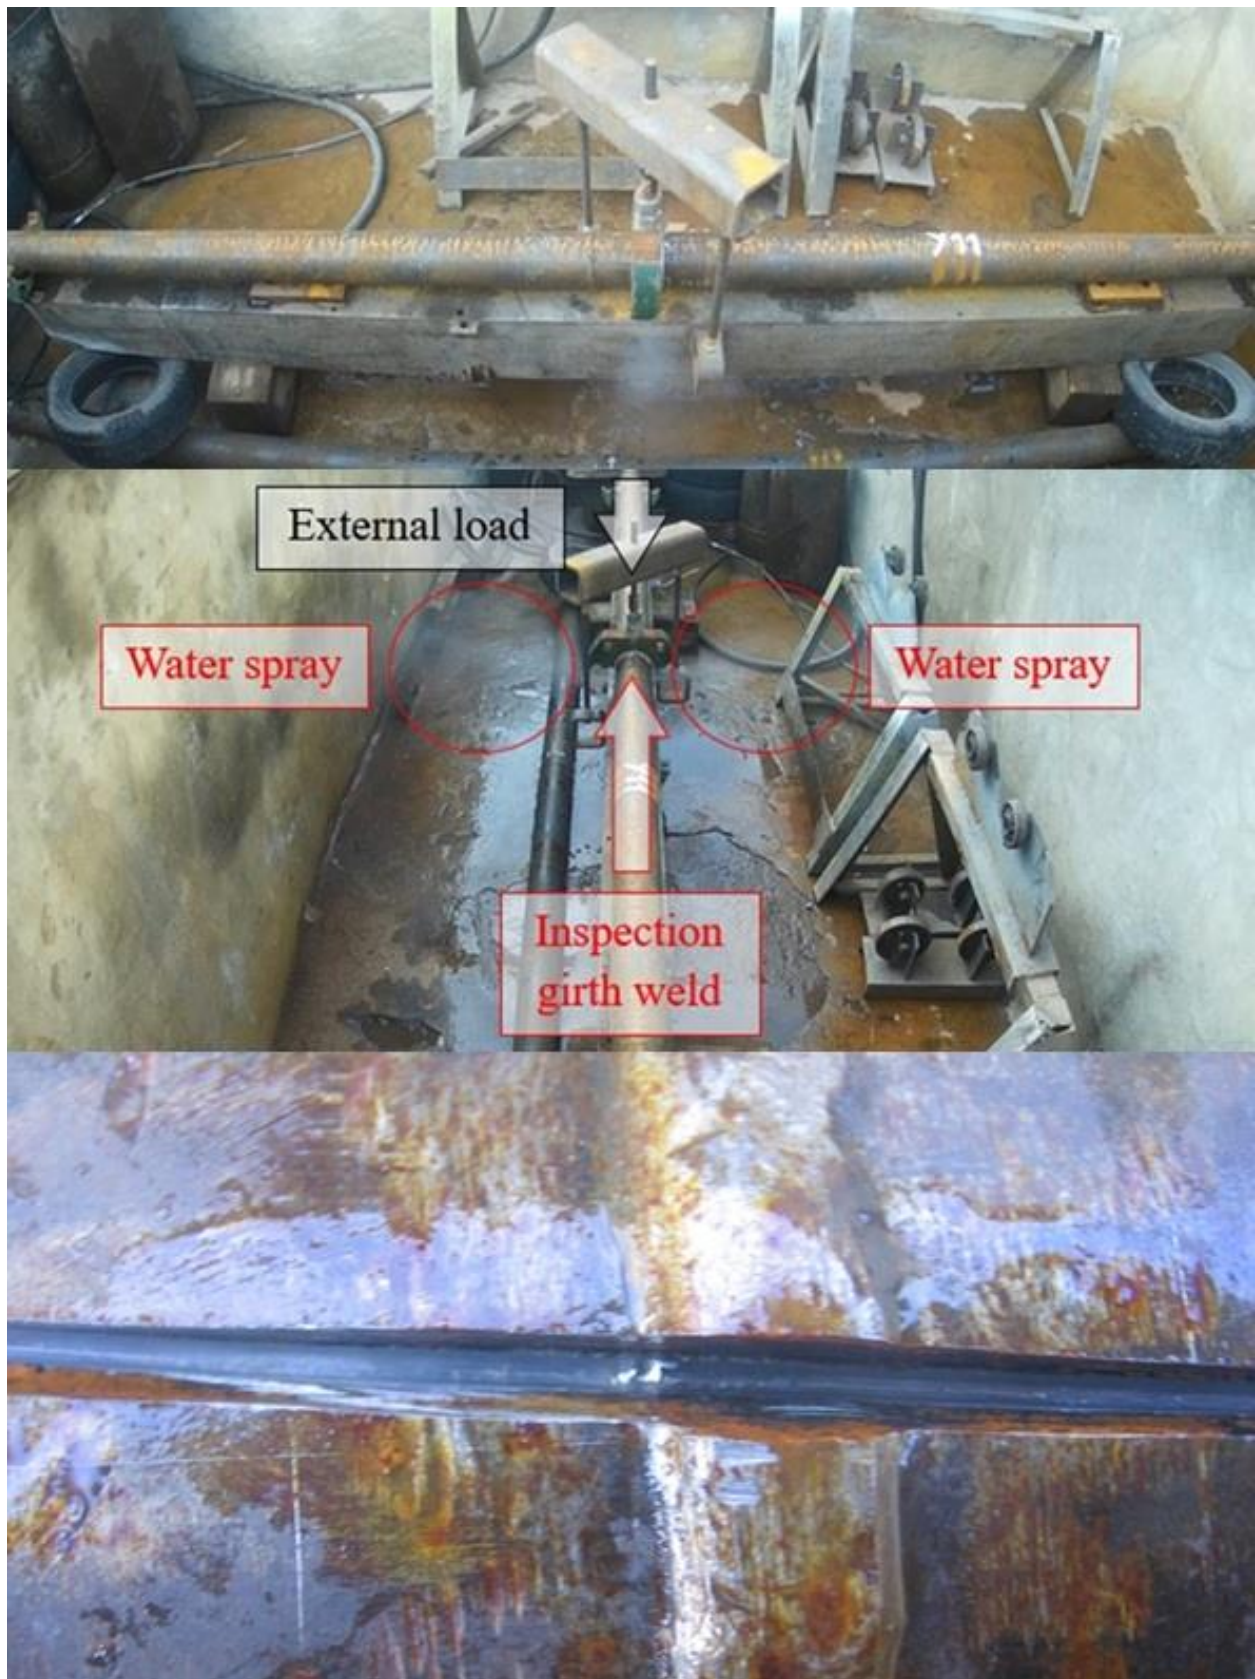
Figure 93 Moment of failure of the Y11 pipeline section during the burst test: side camera image (top), longitudinal camera image (middle), the pipeline section Y11 after the burst test: the damaged section (bottom)

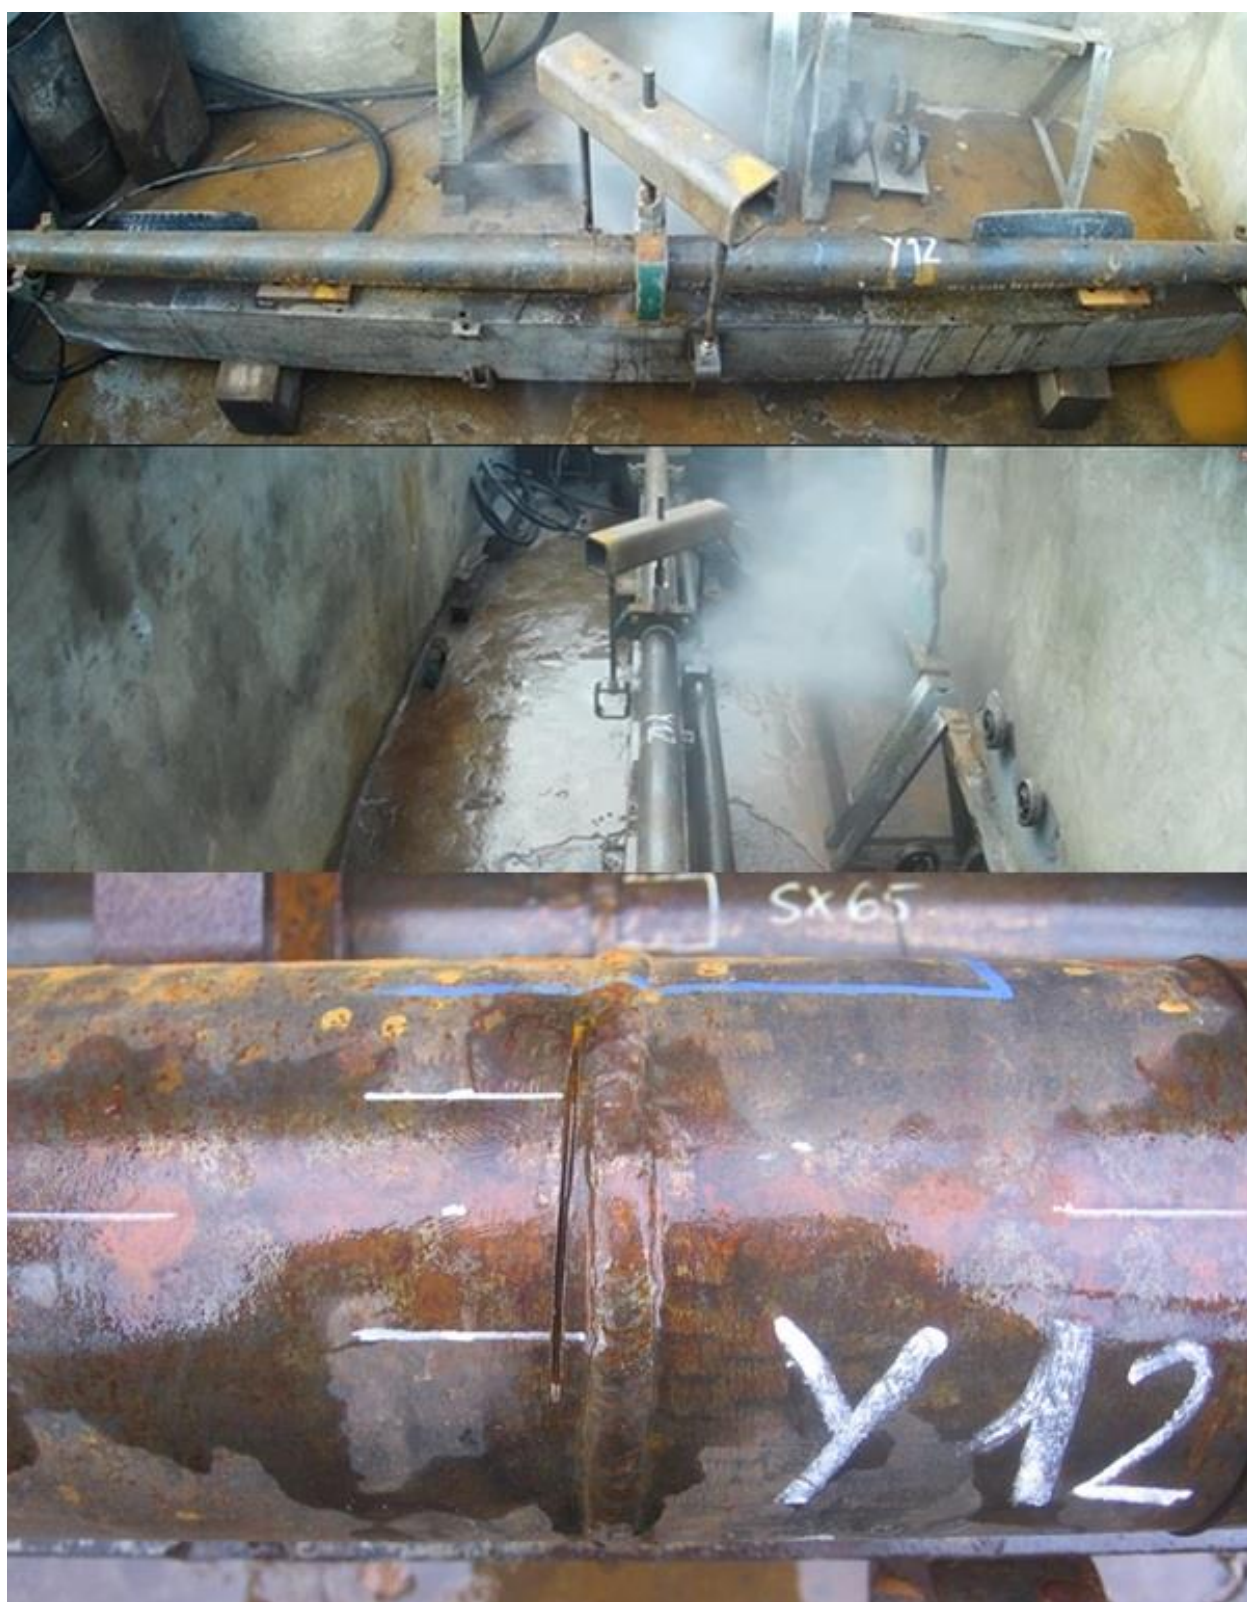
*Figure 94 Moment of failure of the Y12 pipeline section during the burst test: side camera image (top), longitudinal camera image (middle), tested pipe section Y12 after the burst test: the damaged section (bottom)*

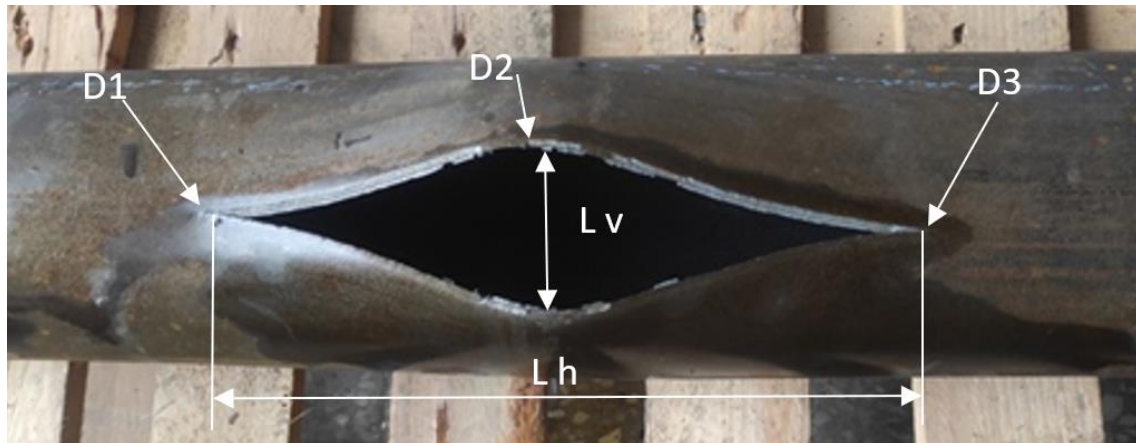
Figure 95 The damage section
