UNIVERSITY OF MISKOLC
FACULTY OF MECHANICAL ENGINEERING AND INFORMATICS

INTEGRITY OF TRANSPORTING PIPELINE GIRTH WELDS BASED ON FULL-SCALE TESTS UNDER COMPLEX LOADING CONDITIONS

Booklet of PhD Theses

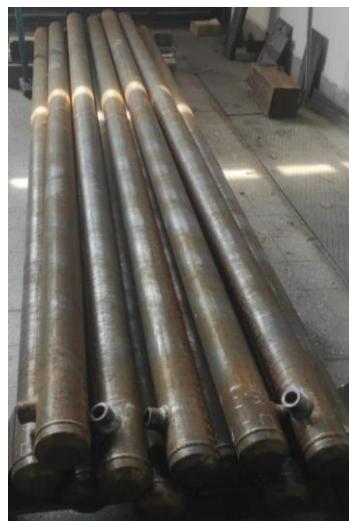
Figure 4 The investigated samples

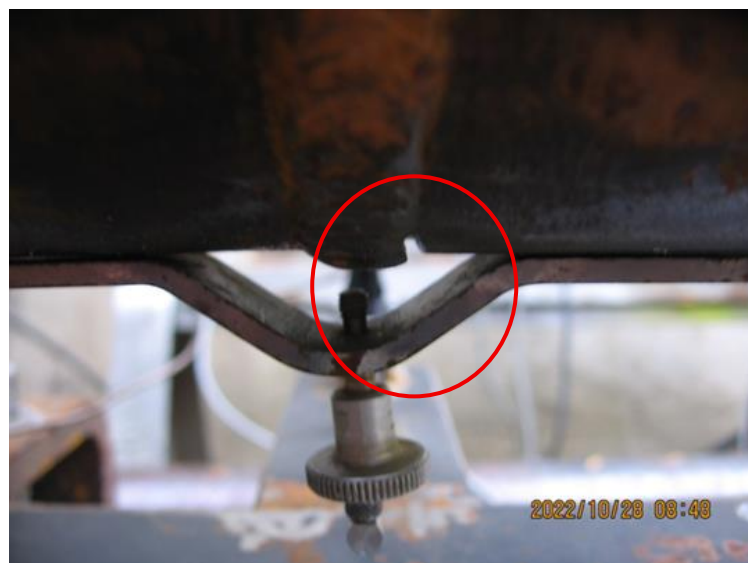
Twelve pipeline sections were tested with different characteristics. The experiences of the Hungarian transporting pipeline operator (FGSZ Ltd.) have pointed to that external undercuts and lack of fusions (between the base materials and weld metals) can be found in inadequate girth welds. Other experiences of the Hungarian transporting pipeline operator have shown that third-party (near) longitudinal damages are also common and significantly increase the operational risk, especially when interacting with both girth and spiral welds. These were the reasons why we also tested girth welds with artificial notches. The notches were cut using a hand grinding machine and located either in the heat-affected zone (HAZ) of the girth weld (circumferential direction) or through the girth weld (axial direction). The external undercuts and lack of fusions were modelled using circumferential notches, the third-party (near) longitudinal damages interacting with girth welds were modelled by longitudinal notches. Since the artificial notches were made by the same person using the same hand grinder, their maximum nominal width was 2 mm. The shape of the artificial notches followed the shape of both the pipe and the grinding wheel (Figure 17), with their width decreasing slightly in the direction of the pipe wall thickness. Figure 18 demonstrates the two types of notch configurations.

Figure 15 The artificial notch configurations

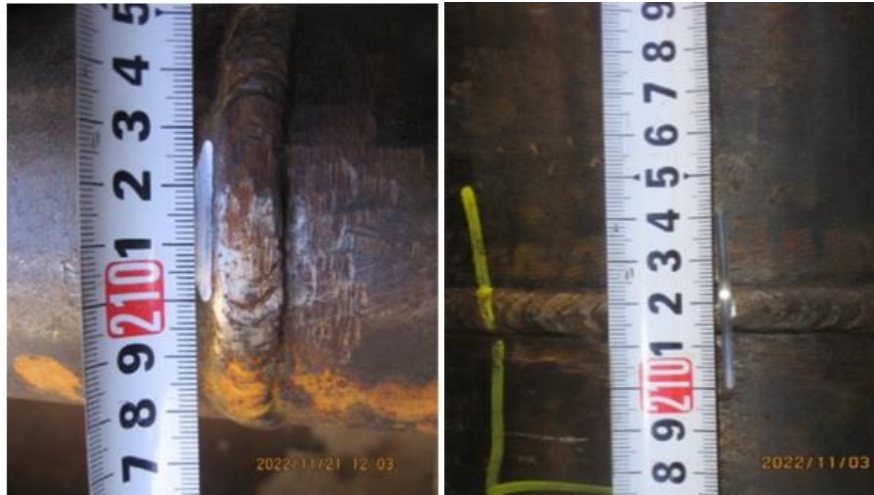
Figure 16 Artificial notch in the girth weld HAZ of the Y10 pipeline section (left), artificial notch through the girth weld of the Y8 pipeline section (right)

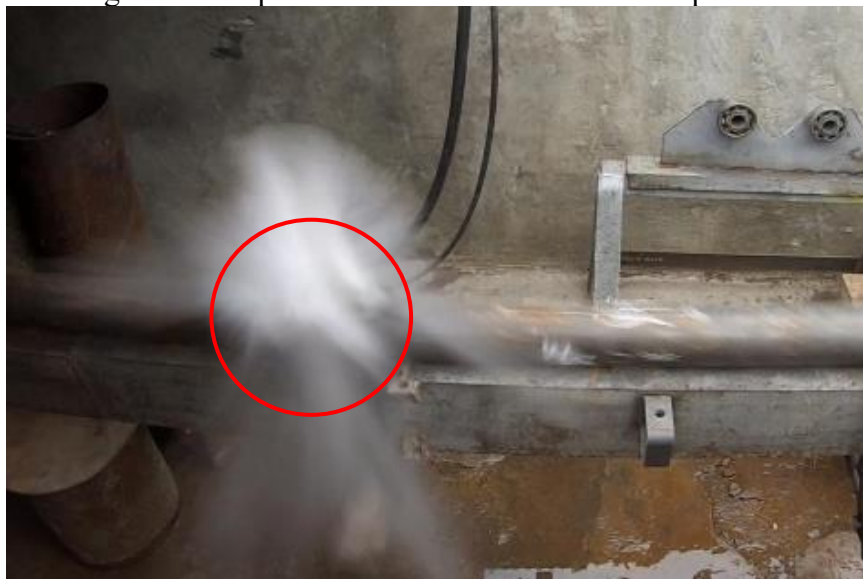
After the burst tests were completed (Figure 22), the video camera recordings were reviewed, the picture-frames corresponding to the moment of failure were cut, and the internal pressure vs. burst test time diagrams were plotted from the recorded internal pressure values (Figure 23).

Figure 22 Y1 pipeline section at the moment of its failures

Images cut from the video recording show clearly and distinctly in which cases the failure occurred on the pipe body and in which cases it occurred in the tested girth weld.

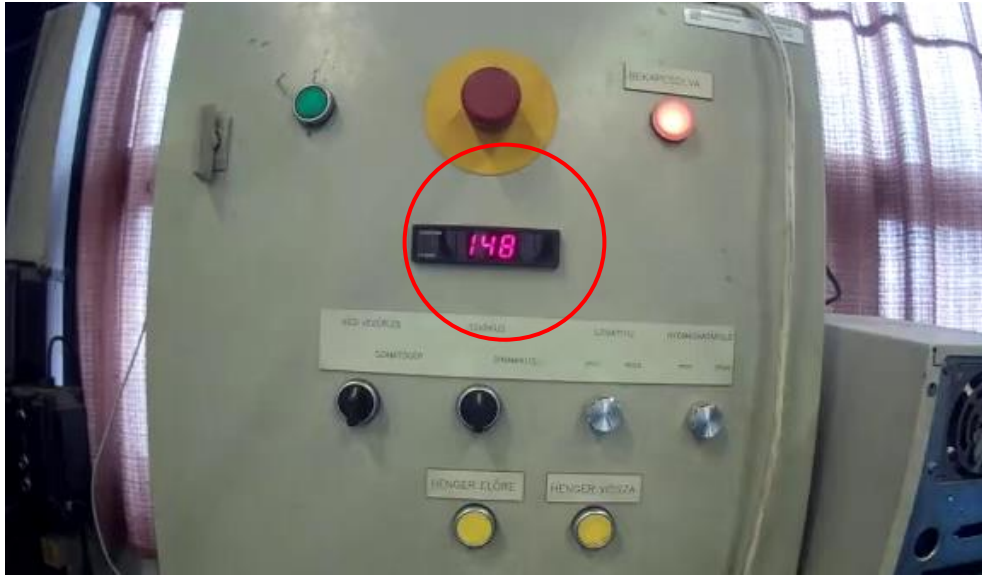
Figure 23 The pressure value during the burst test (example)
